# the **play inspection** company

## Annual Inspection

Kimpton Parish Council - Recreation Ground

Inspection Ref: 1498980

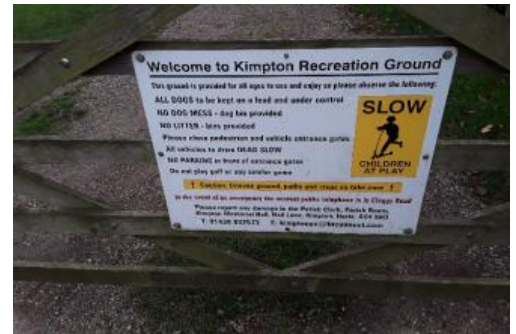
**Item:** Sign  
**Manufacturer:** Owner/Operator  
**Surface Type:** N/A  
**Item Quantity:** 1  
**Equipment Compliance:** N/A  
**Surface Area Compliance:** N/A

This item is satisfactory - no work required -

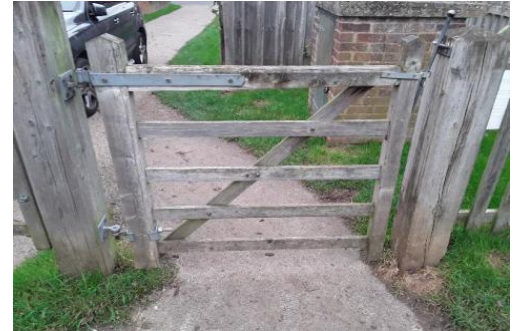
**Item:** Gate  
**Manufacturer:** Not Identified  
**Surface Type:** Concrete  
**Item Quantity:** 1  
**Equipment Compliance:** N/A  
**Surface Area Compliance:** N/A

There are openings that are less than 12mm that could trap or crush fingers - Where possible a 12mm gap should be maintained on both sides or between the gate leaves

The gate is snagging on the surrounding surface preventing it from closing correctly - Carry out remedial works to ensure the gate closes correctly

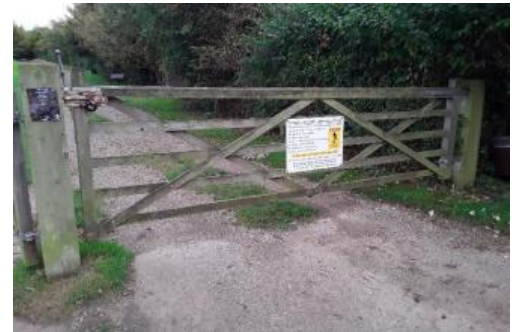
**Item:** Gate - Maintenance  
**Manufacturer:** Not Identified  
**Surface Type:** Gravel  
**Item Quantity:** 1  
**Equipment Compliance:** N/A  
**Surface Area Compliance:** N/A

This item is satisfactory - no work required -

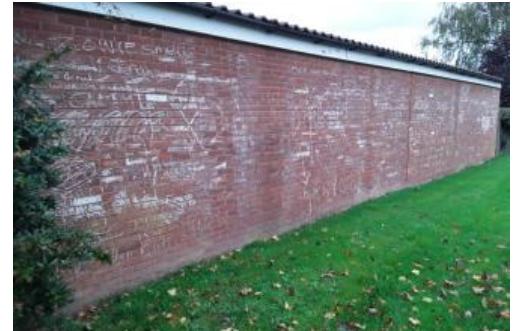
**Item:** Brick Wall  
**Manufacturer:** Owner/Operator  
**Surface Type:** N/A  
**Item Quantity:** 1  
**Equipment Compliance:** N/A  
**Surface Area Compliance:** N/A

This item is satisfactory - no work required -

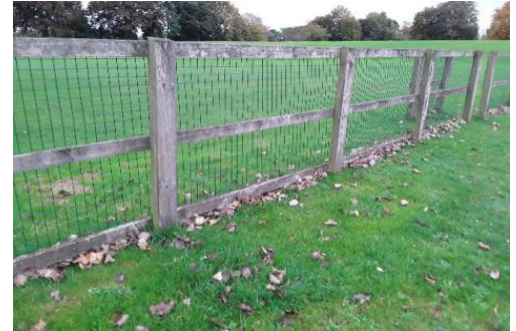
**Item:** Fencing - Post & Rail  
**Manufacturer:** Owner/Operator  
**Surface Type:** N/A  
**Item Quantity:** 1  
**Equipment Compliance:** N/A  
**Surface Area Compliance:** N/A

Parts of the timber are rough or splintered - Remove all rough or sharp edges

There is some evidence of rot in the timber - Monitor for any further deterioration and replace as required

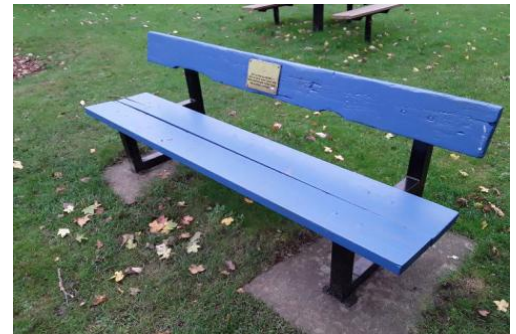
**Item:** Bench  
**Manufacturer:** Owner/Operator  
**Surface Type:** N/A  
**Item Quantity:** 2  
**Equipment Compliance:** N/A  
**Surface Area Compliance:** N/A

Parts of the timber are rough or splintered - Remove all rough or sharp edges

There is some evidence of rot in the timber - Monitor for any further deterioration and replace as required

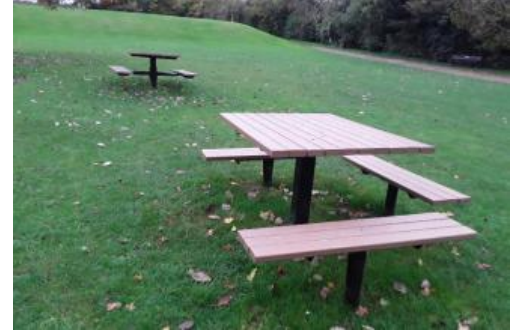
**Item:** Picnic Table  
**Manufacturer:** Owner/Operator  
**Surface Type:** N/A  
**Item Part Number:**  
**Item Quantity:** 2  
**Equipment Compliance:** N/A  
**Surface Area Compliance:** N/A  
**Total Findings:** 1

This item is satisfactory - no work required -

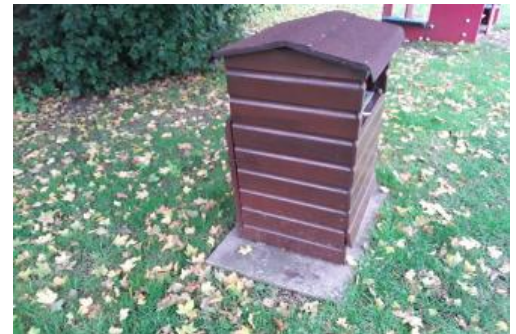
**Item:** Litter Bin  
**Manufacturer:** Owner/Operator  
**Surface Type:** N/A  
**Item Quantity:** 1  
**Equipment Compliance:** N/A  
**Surface Area Compliance:** N/A  
**Total Findings:** 1

This item is satisfactory - no work required -

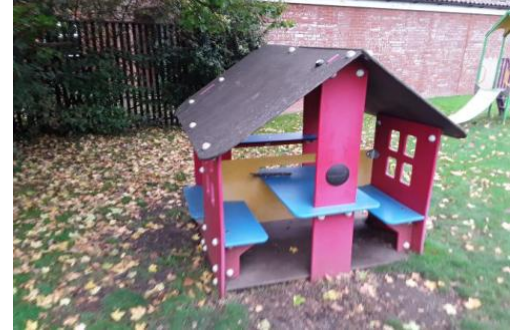
**Item:** Playhouse  
**Manufacturer:** Kompan Ltd  
**Surface Type:** Grass  
**Item Quantity:** 1  
**Equipment Compliance:** Yes  
**Surface Area Compliance:** N/A

There is/are bolt cap covers missing or damaged on the item - Replace missing or damaged bolt cap covers

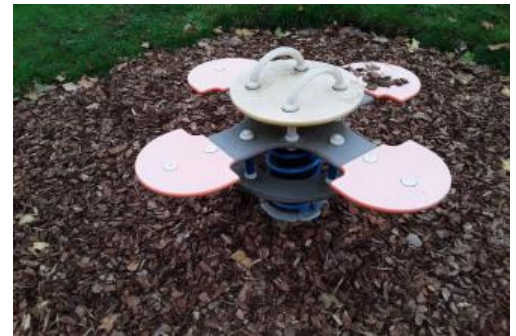
**Item:** Spring Crazy Daisy  
**Manufacturer:** Kompan Ltd  
**Surface Type:** Bark Mulch  
**Item Part Number:**  
**Item Quantity:** 1  
**Equipment Compliance:** Yes  
**Surface Area Compliance:** Yes  
**Total Findings:** 1

This item is satisfactory - no work required -

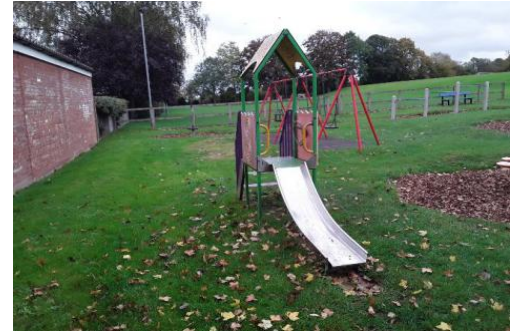
**Item:** Multi Play (Toddler)  
**Manufacturer:** Wicksteed Playgrounds  
**Surface Type:** Grass  
**Item Quantity:** 1  
**Equipment Compliance:** No  
**Surface Area Compliance:** Yes

There is/are finger entrapment/s adjacent to the slide entry and the item fails to meet the requirements of BS EN 1176 Part 1 4.2.7.6 Entrapment of fingers - Monitor - No remedial work recommended

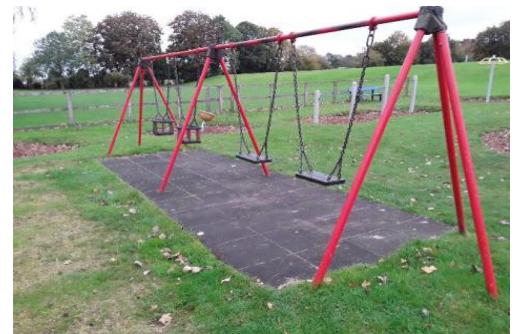
**Item:** 2 Bay 2 Flat 2 Cradle  
**Manufacturer:** Wicksteed Playgrounds  
**Surface Type:** Grass  
**Item Quantity:** 1  
**Equipment Compliance:** No  
**Surface Area Compliance:** Yes

There are trip hazards at the edges of the tiles - Reinstate surrounding surface levels to remove the trip points

The bushes are showing signs of wear - Monitor for any further deterioration and replace as required

The chain openings are in excess of the 8.6mm as recommended by BS EN 1176 - Monitor - No remedial work recommended

There is some notable evidence of chain wear - Monitor for any further deterioration and replace when 40% worn

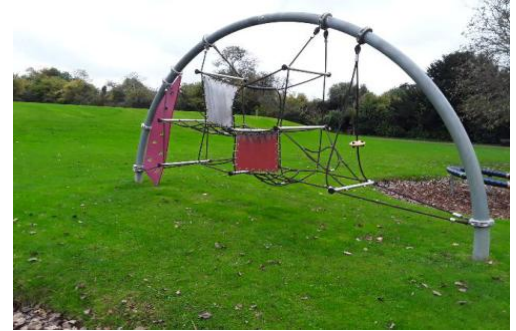
**Item:** Climbing Frame  
**Manufacturer:** S M P (Playgrounds Ltd)  
**Surface Type:** Grass Matrix Tiles  
**Item Quantity:** 1  
**Equipment Compliance:** Yes  
**Surface Area Compliance:** Yes

The ropes/nets are worn/damaged in places - Monitor for any further deterioration and repair or replace as required

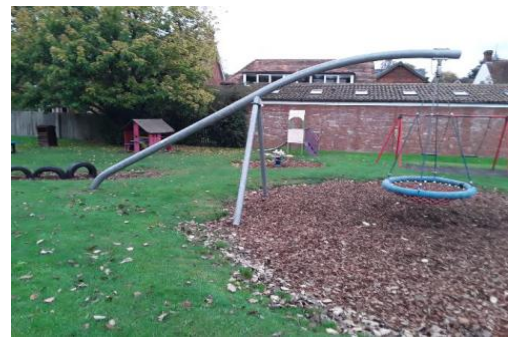
**Item:** Single Point Swing - Type 3  
**Manufacturer:** Monster Play Systems  
**Surface Type:** Bark Mulch  
**Item Quantity:** 1  
**Equipment Compliance:** No  
**Surface Area Compliance:** Yes

The ropes/nets are worn/damaged in places - Monitor for any further deterioration and repair or replace as required

The connecting links are in excess of 8.6mm and less than 12mm and fail the requirements of BS EN 1176 Part 1; clause 4.2.13, Chains - Monitor - No remedial work recommended

There is some notable evidence of chain wear - Monitor for any further deterioration and replace when 40% worn

The connecting lugs are showing signs of wear - Monitor for any further deterioration and repair as required

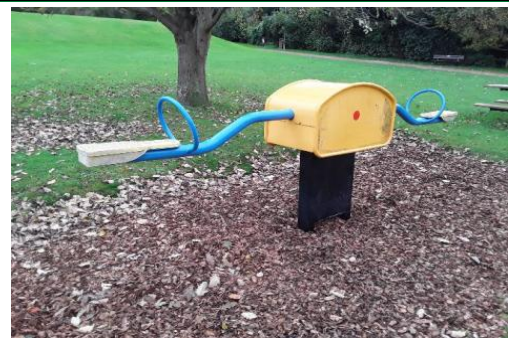
**Item:** See Saw  
**Manufacturer:** Wicksteed Playgrounds  
**Surface Type:** Grass  
**Item Quantity:** 1  
**Equipment Compliance:** Yes  
**Surface Area Compliance:** Yes

There is some graffiti present - Remove the graffiti

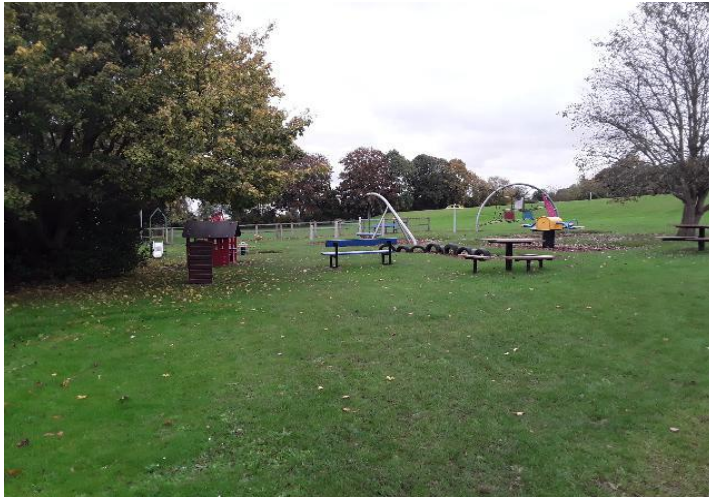
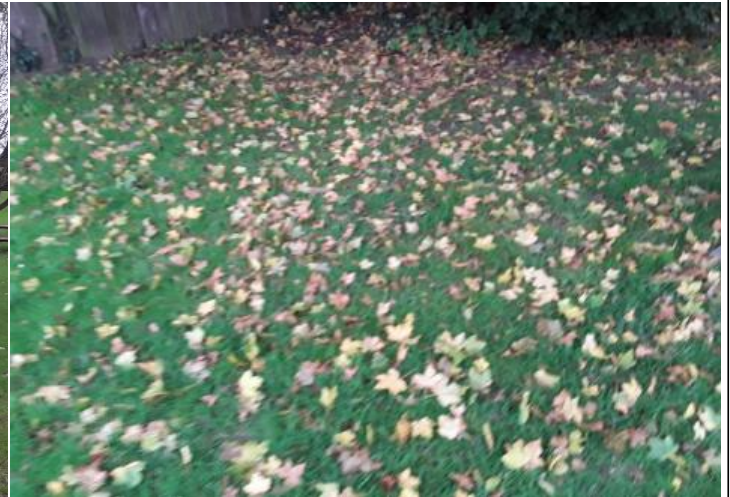
**Item:** Ancillary Items - Site General  
**Manufacturer:** Owner/Operator

**Finding:** There is tree debris on the surfacing

**Action:** Remove and maintain

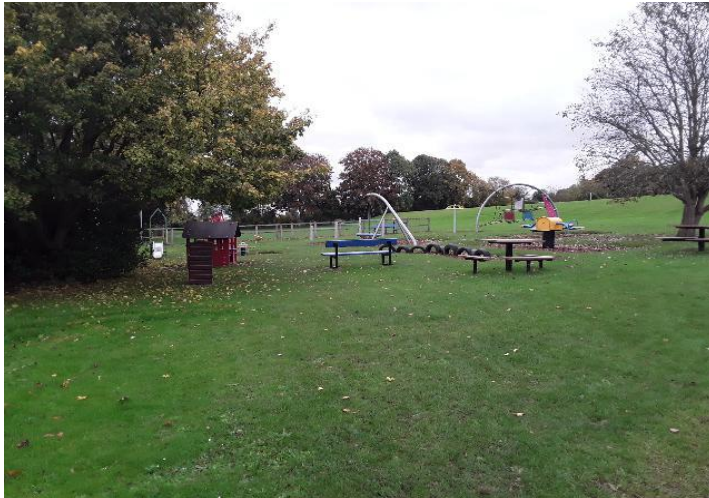
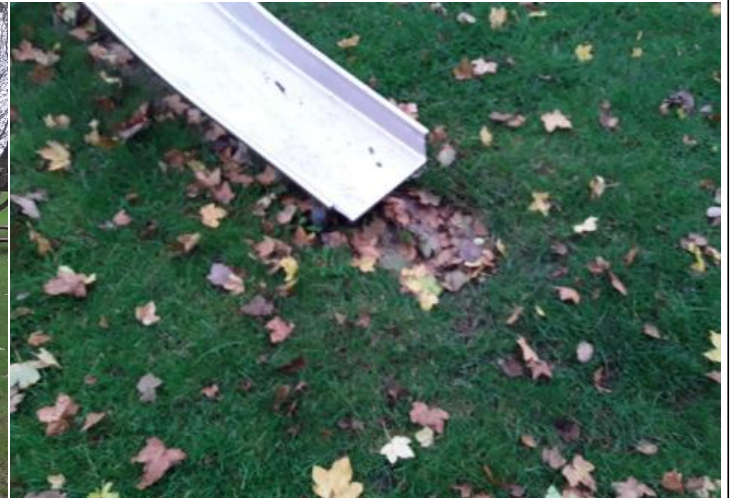
**Item:** Ancillary Items - Site General  
**Manufacturer:** Owner/Operator

**Finding:** The grass mats are silted up, the soil is compacted and the area will become very slippery when the soil is wet. **Action:** Reinstate as required

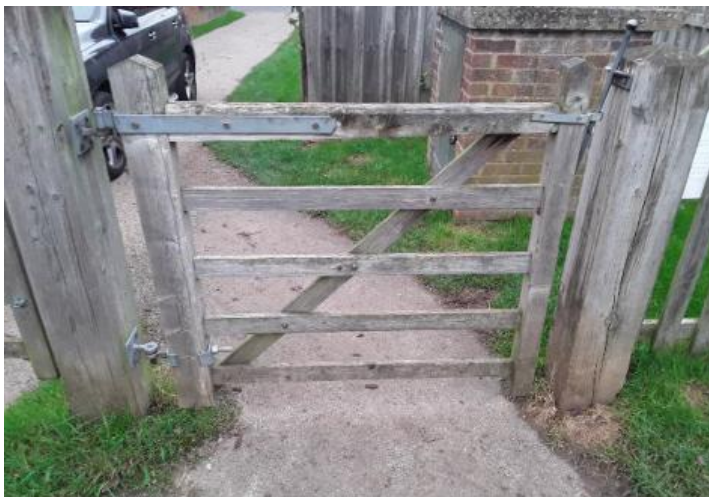
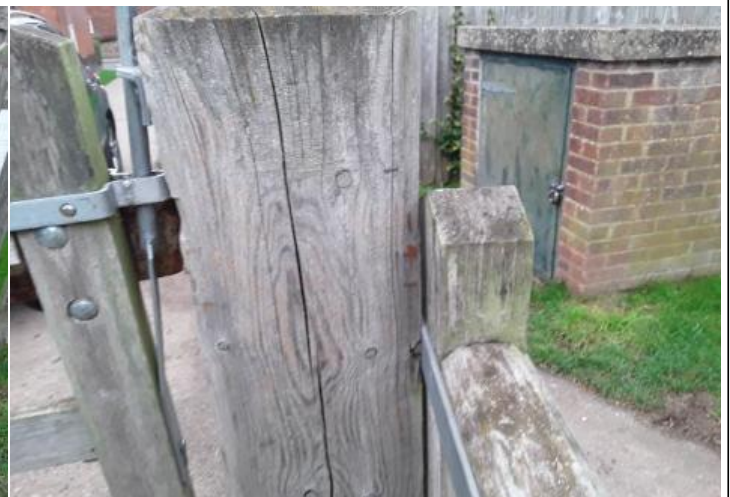
**Item:** Gates - Gate  
**Manufacturer:** Not Identified

**Finding:** There are openings that are less than 12mm that could trap or crush fingers **Action:** Where possible a 12mm gap should be maintained on both sides or between the gate leaves

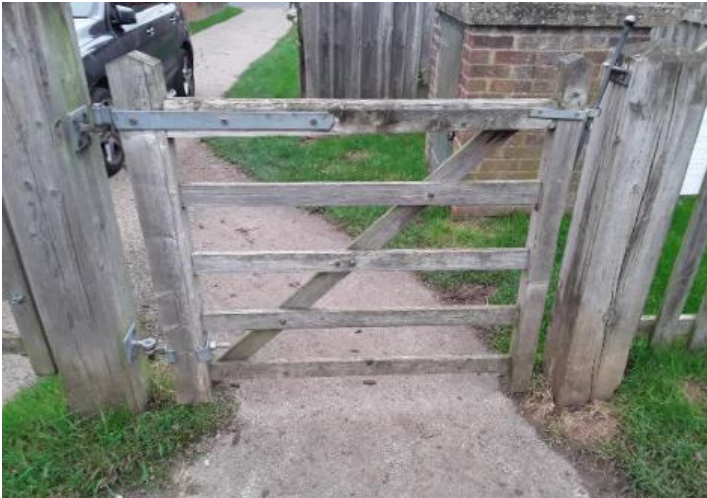
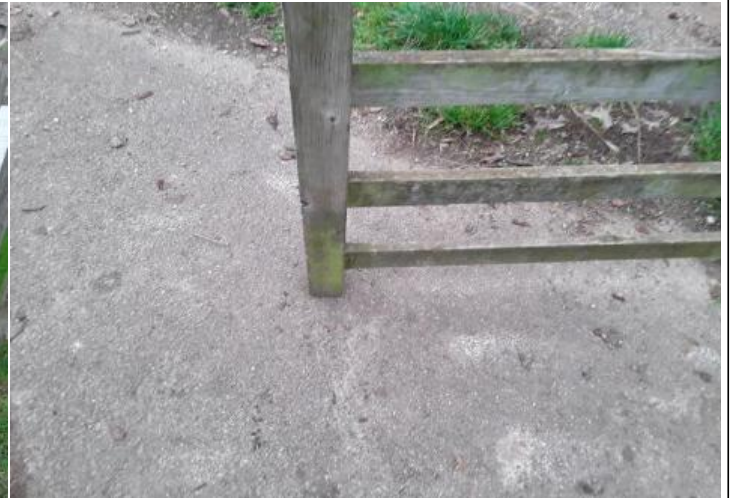
**Item:** Gates - Gate  
**Manufacturer:** Not Identified

**Finding:** The gate is snagging on the surrounding surface preventing it from closing correctly

**Action:** Carry out remedial works to ensure the gate closes correctly

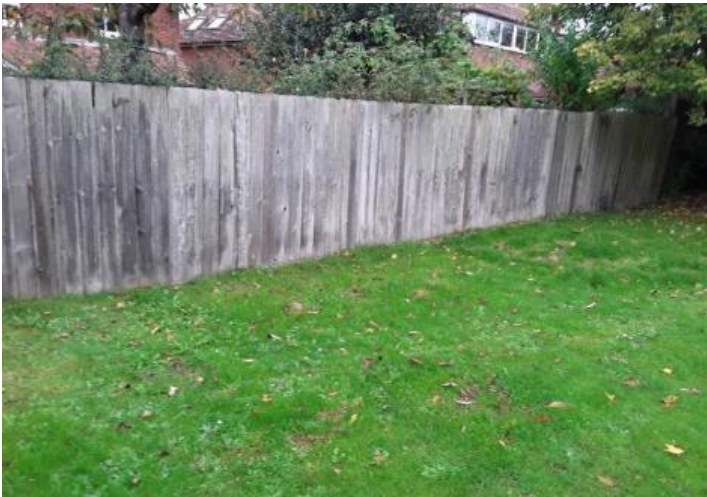
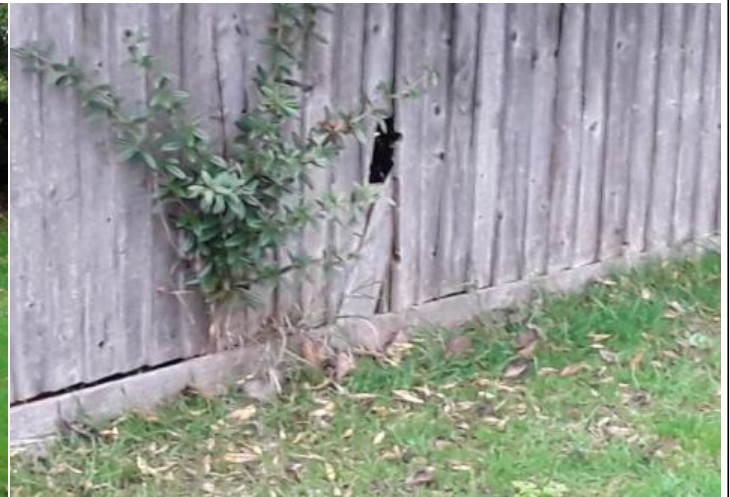
**Item:** Fences - Fencing - Timber  
**Manufacturer:** Not Identified

**Finding:** There is some damage to the fence sections

**Action:** Monitor for any further deterioration and repair as required

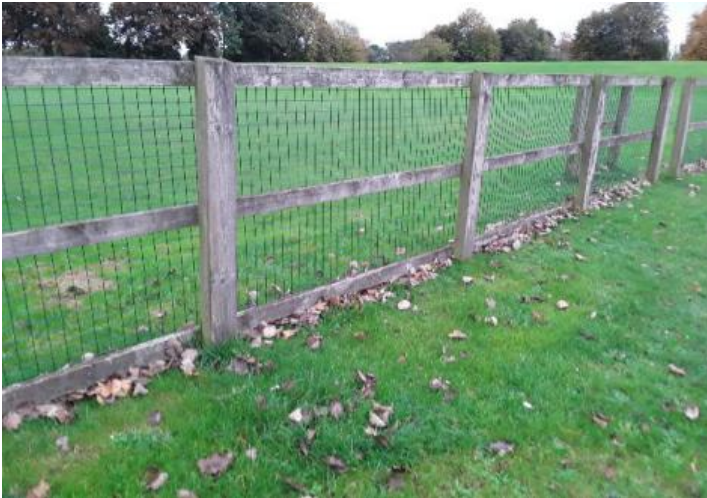
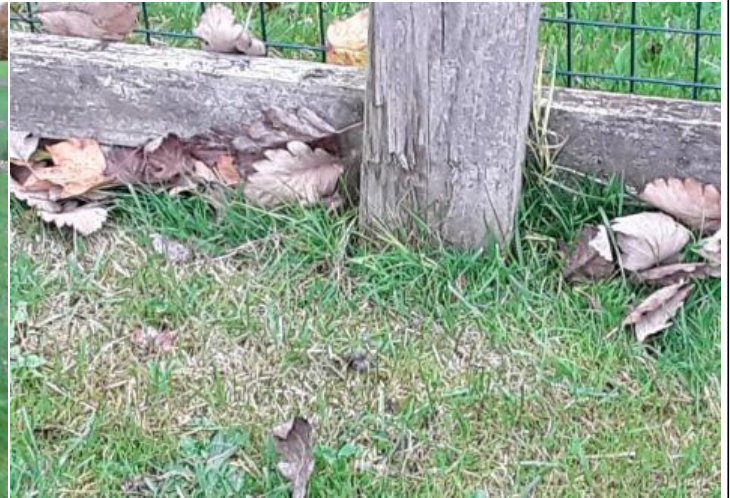
**Item:** Fences - Fencing - Post & Rail  
**Manufacturer:** Owner/Operator

**Finding:** Parts of the timber are rough or splintered

**Action:** Remove all rough or sharp edges

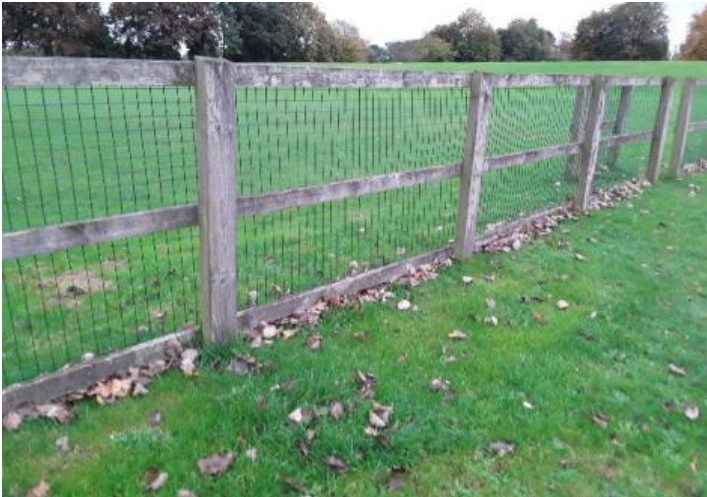
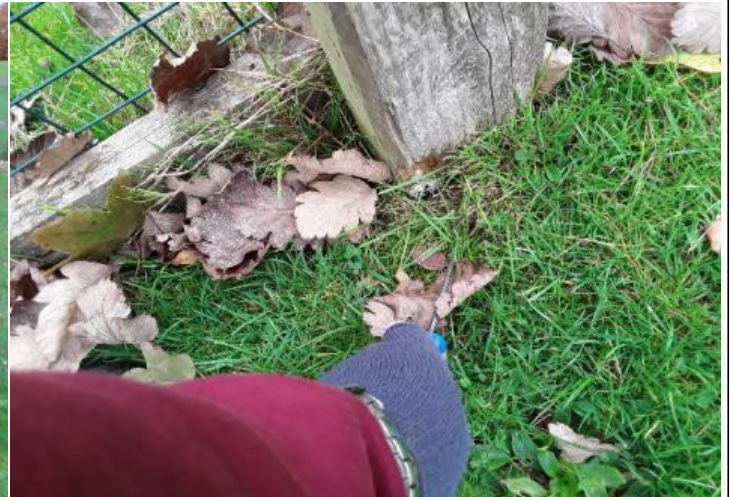
**Item:** Fences - Fencing - Post & Rail  
**Manufacturer:** Owner/Operator

**Finding:** There is some evidence of rot in the timber

**Action:** Monitor for any further deterioration and replace as required

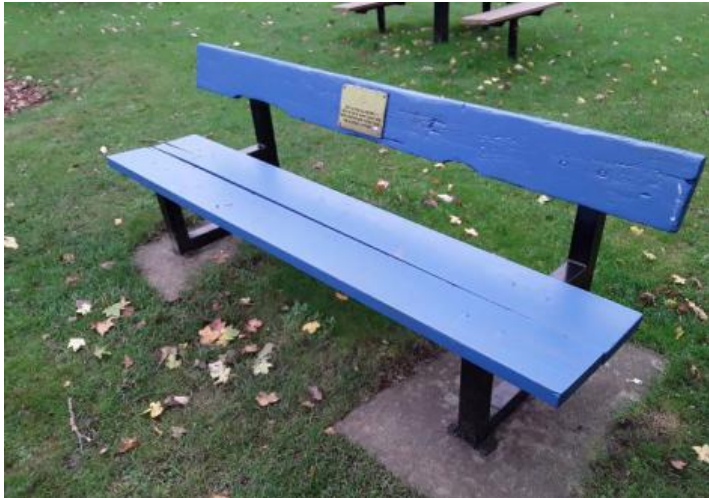
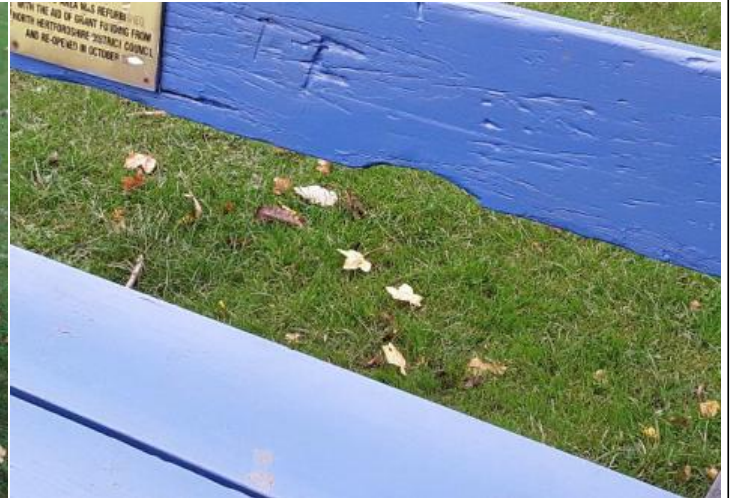
**Item:** Ancillary Items - Bench  
**Manufacturer:** Owner/Operator

**Finding:** Parts of the timber are rough or splintered

**Action:** Remove all rough or sharp edges

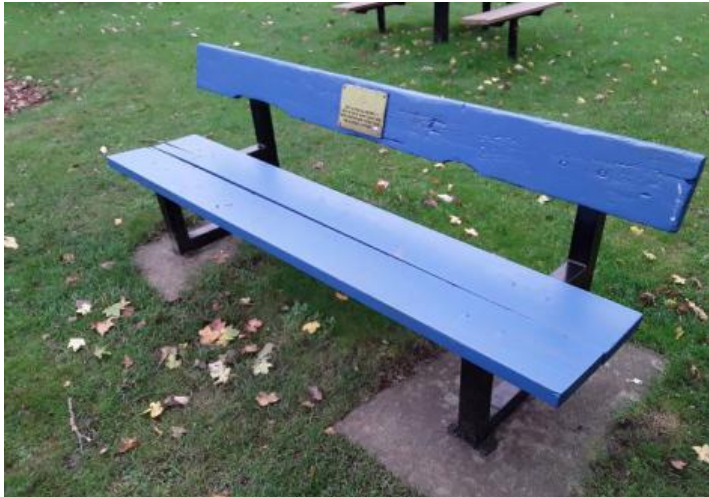
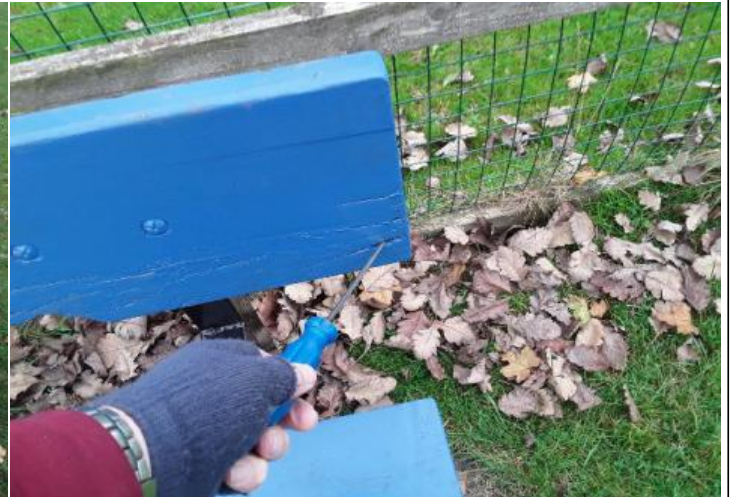
**Item:** Ancillary Items - Bench  
**Manufacturer:** Owner/Operator

**Finding:** There is some evidence of rot in the timber

**Action:** Monitor for any further deterioration and replace as required

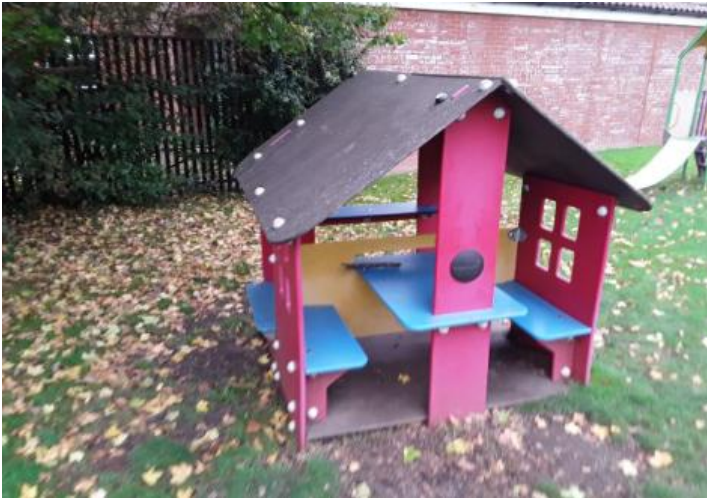
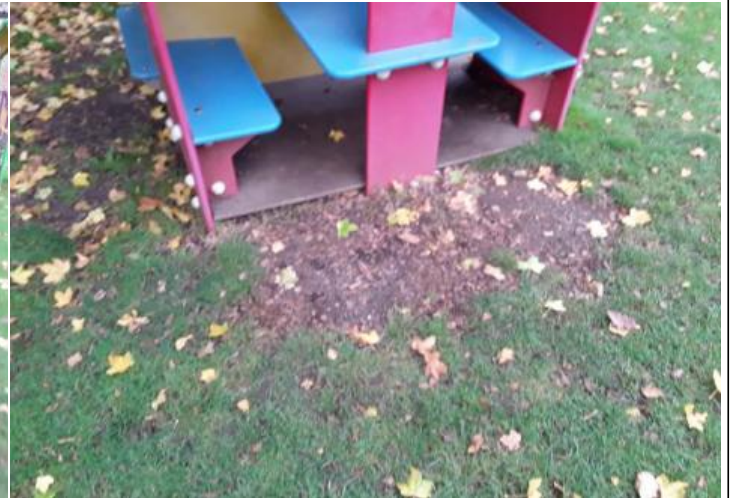
**Item:** Activity Equipment - Playhouse  
**Manufacturer:** Kompan Ltd

**Finding:** The area around the item has eroded and may become slippery

**Action:** Reinststate eroded area

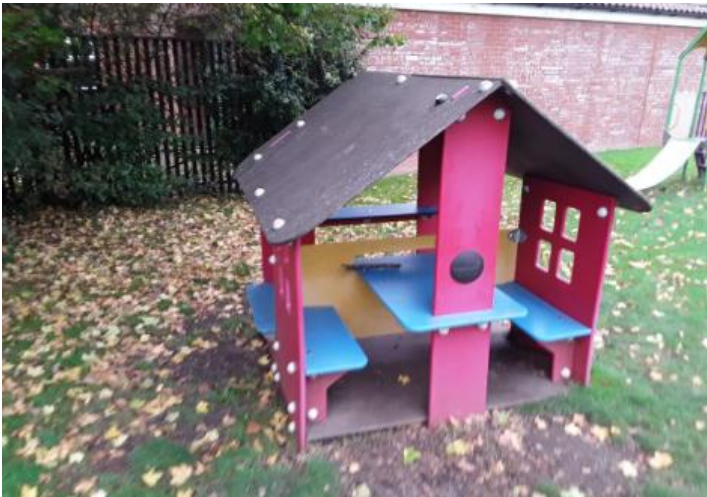
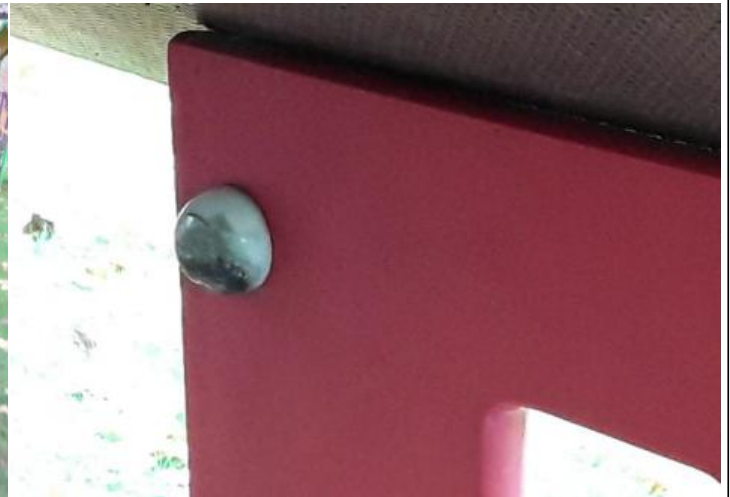
**Item:** Activity Equipment - Playhouse  
**Manufacturer:** Kompan Ltd

**Finding:** There is/are bolt cap covers missing or damaged on the item

**Action:** Replace missing or damaged bolt cap covers

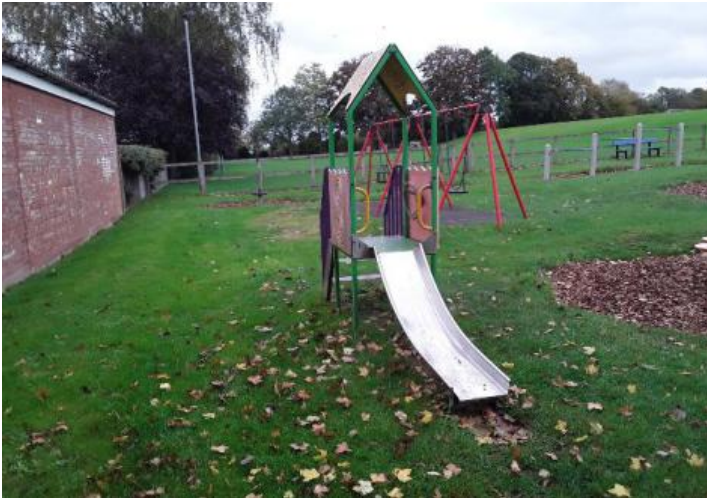
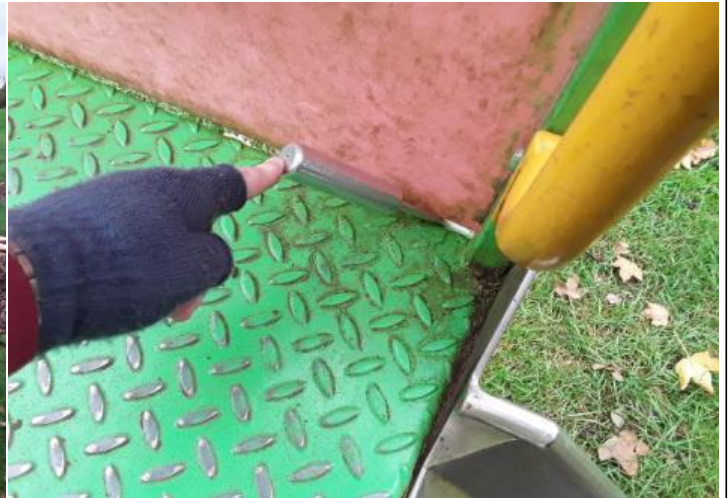
**Item:** Activity Equipment - Multi Play (Toddler)  
**Manufacturer:** Wicksteed Playgrounds

**Finding:** There is/are finger entrapment/s adjacent to the slide entry and the item fails to meet the requirements of BS EN 1176 Part 1 4.2.7.6 Entrapment of fingers

**Action:** Monitor - No remedial work recommended

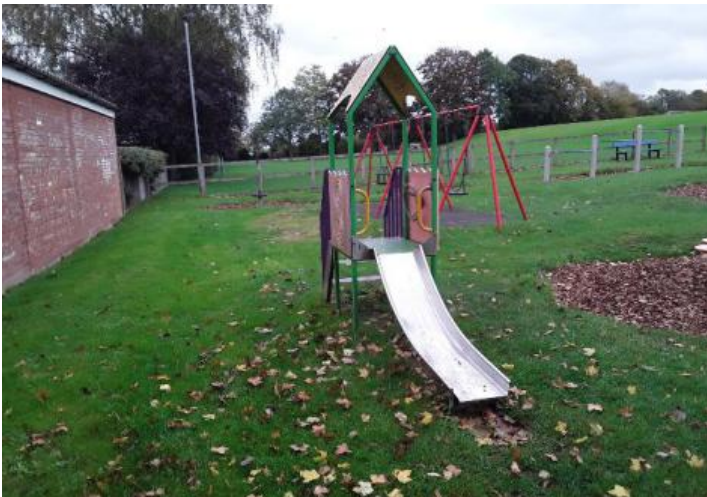
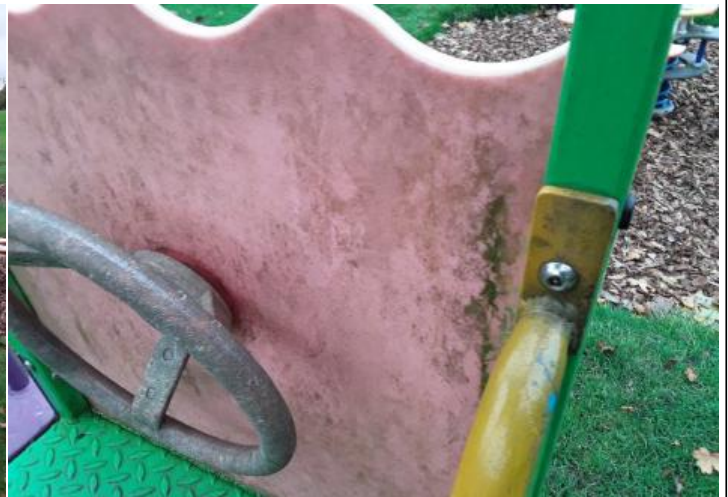
**Finding:** There is algae or moss on the surface of the equipment

**Action:** Clean and treat appropriately

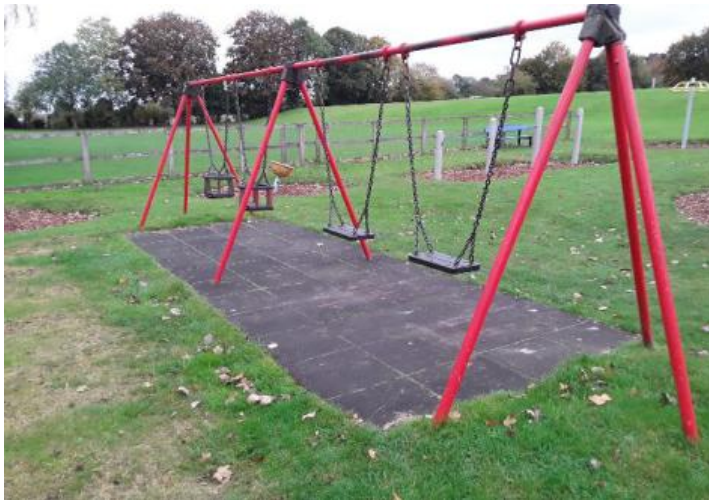
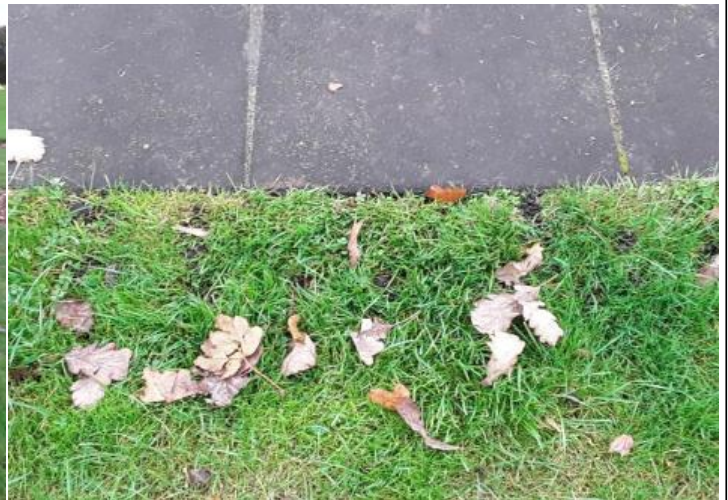
**Item:** Swings - 2 Bay 2 Flat 2 Cradle  
**Manufacturer:** Wicksteed Playgrounds

**Finding:** There are trip hazards at the edges of the tiles

**Action:** Reinstate surrounding surface levels to remove the trip points

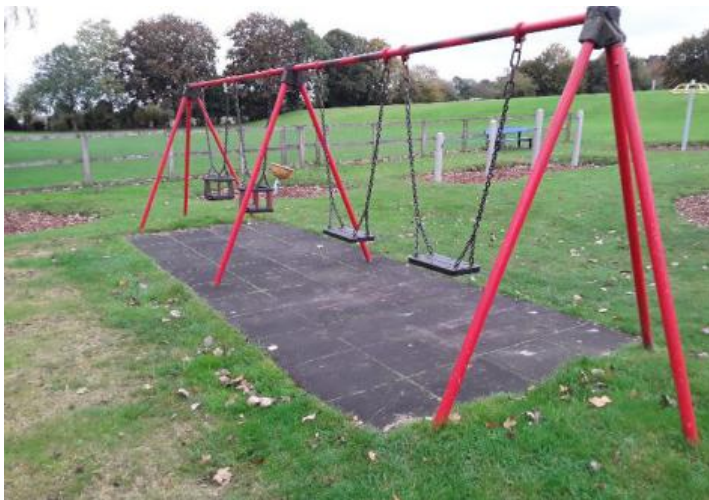
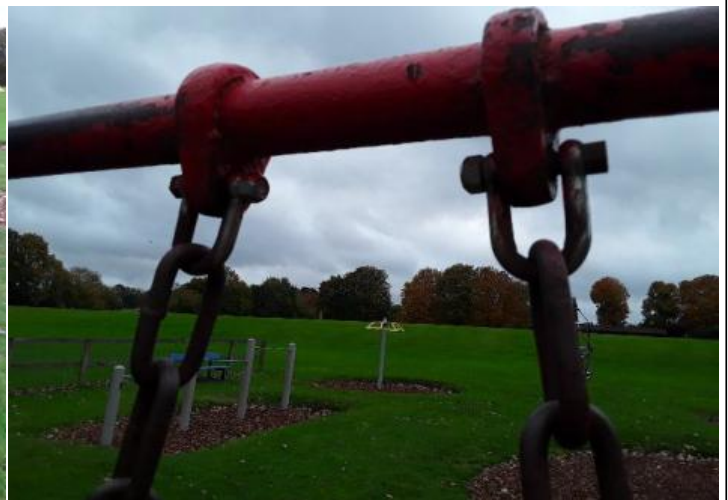
**Finding:** The bushes are showing signs of wear

**Action:** Monitor for any further deterioration and replace as required

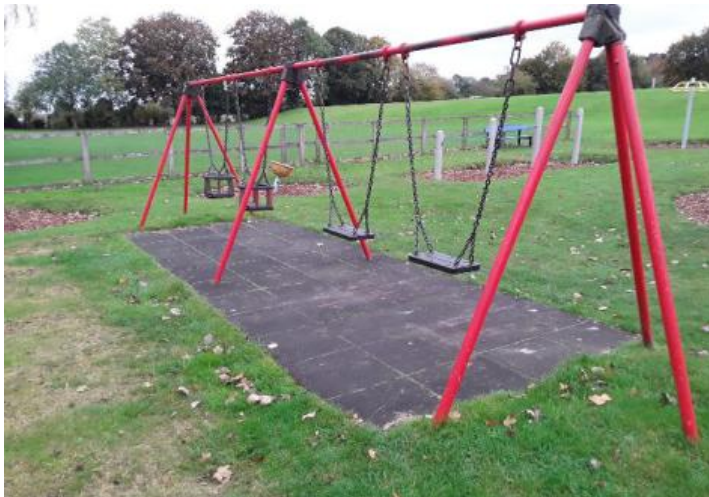
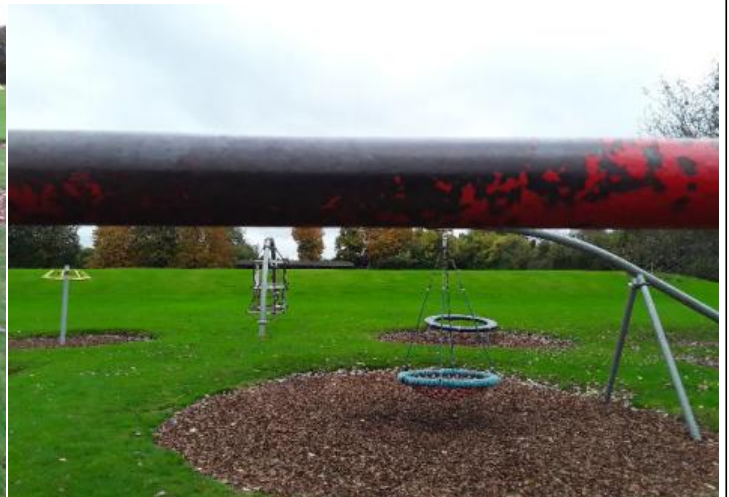
**Finding:** The paint is flaking off the metalwork

**Action:** Rub down and re-paint

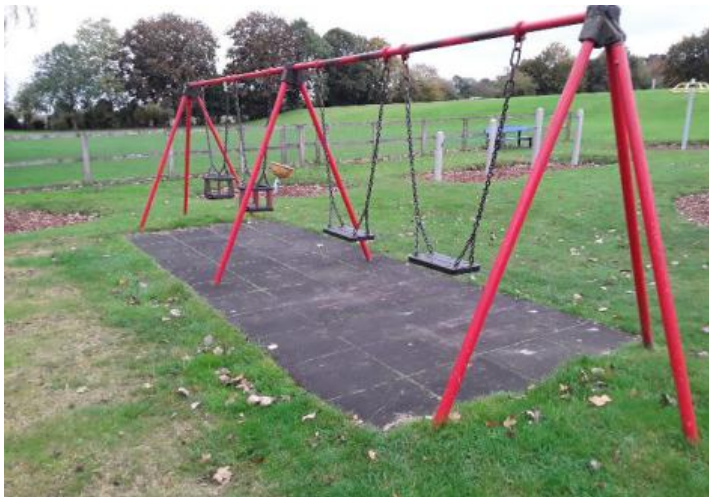
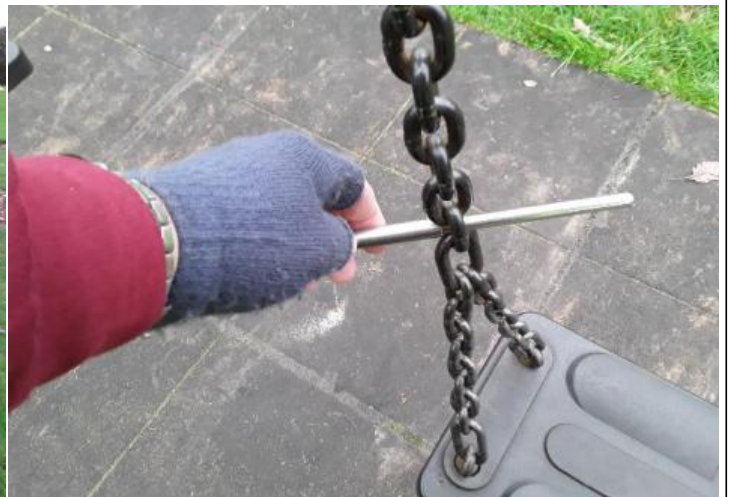
**Finding:** The chain openings are in excess of the 8.6mm as recommended by BS EN 1176

**Action:** Monitor - No remedial work recommended

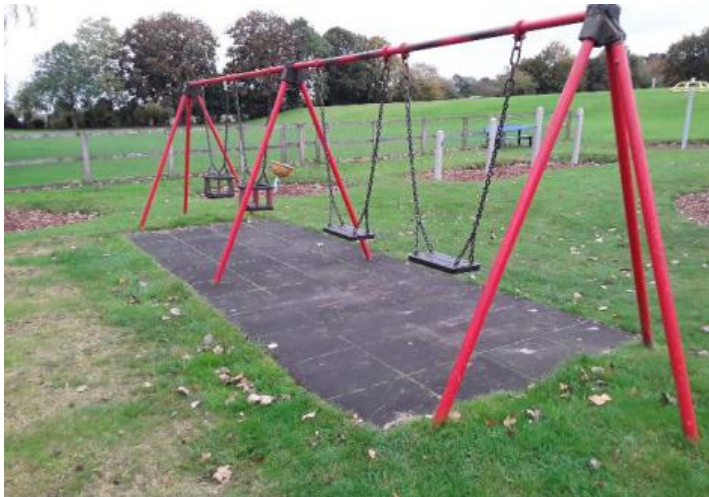
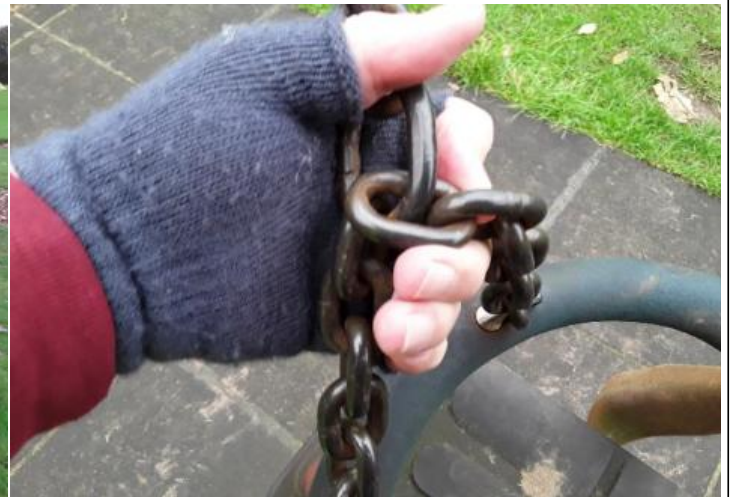
**Finding:** There is some notable evidence of chain wear

**Action:** Monitor for any further deterioration and replace when 40% worn

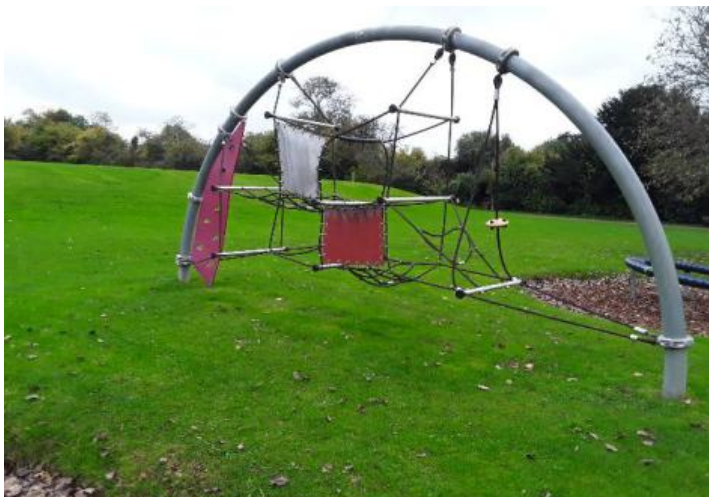
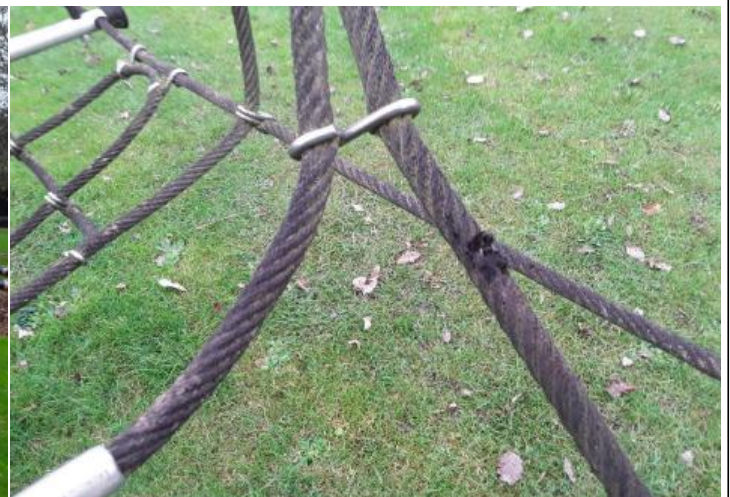
**Finding:** The ropes/nets are worn/damaged in places

**Action:** Monitor for any further deterioration and repair or replace as required

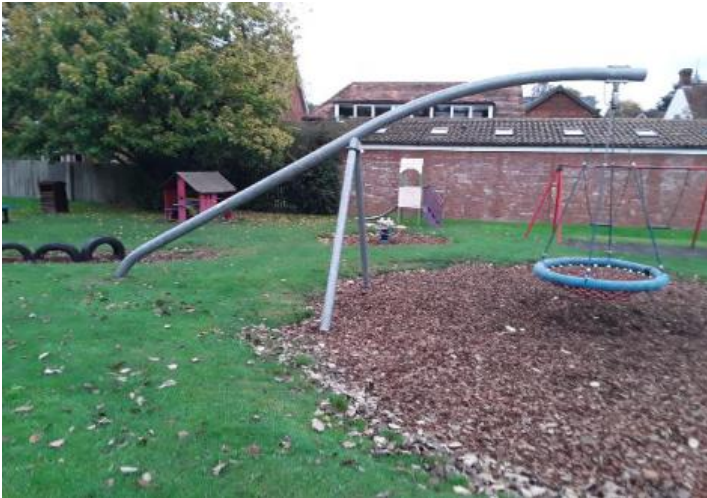
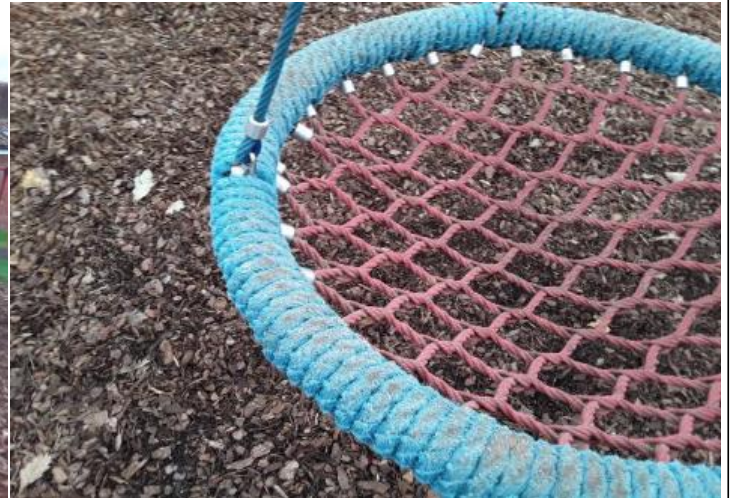
**Finding:** The ropes/nets are worn/damaged in places

**Action:** Monitor for any further deterioration and repair or replace as required

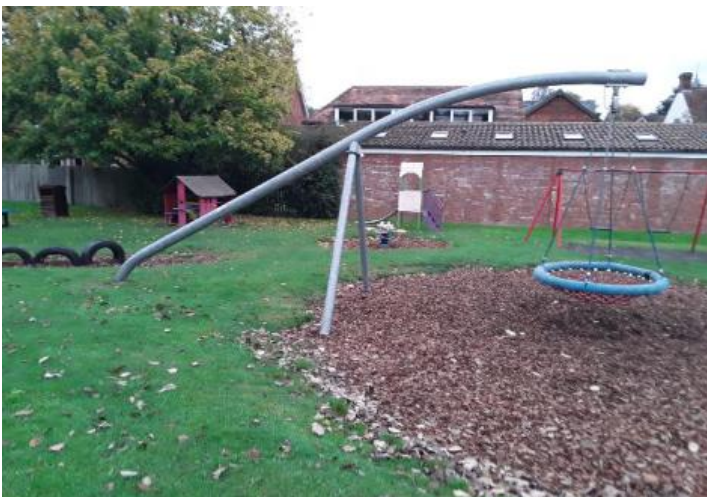
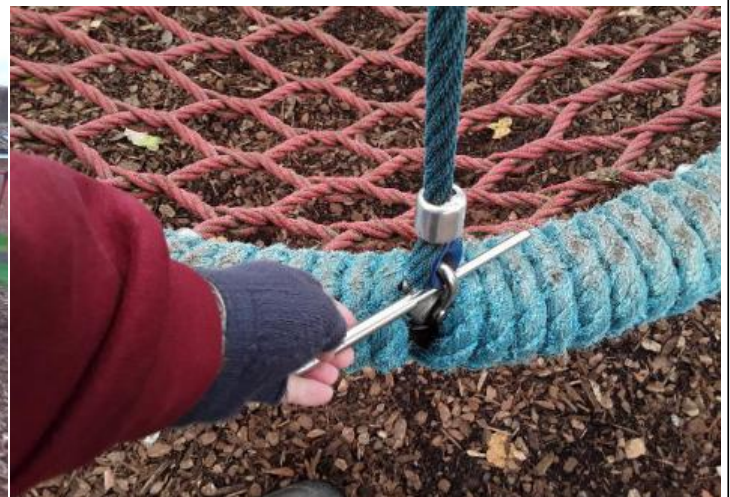
**Finding:** The connecting links are in excess of 8.6mm and less than 12mm and fail the requirements of BS EN 1176 Part 1; clause 4.2.13, Chains

**Action:** Monitor - No remedial work recommended

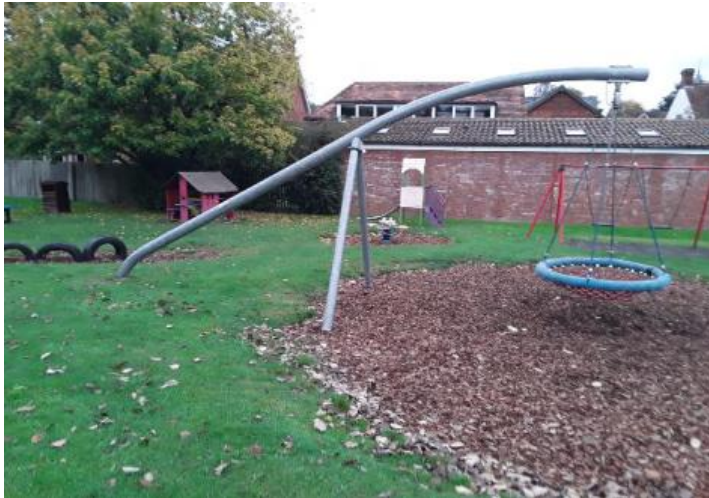
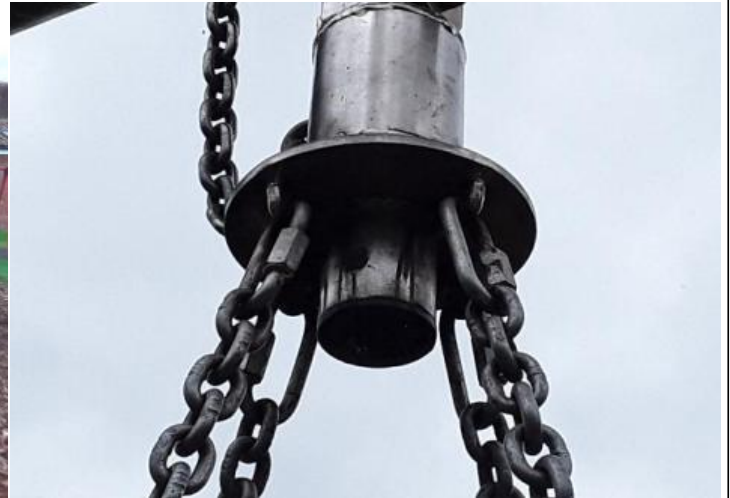
**Finding:** There is some notable evidence of chain wear

**Action:** Monitor for any further deterioration and replace when 40% worn

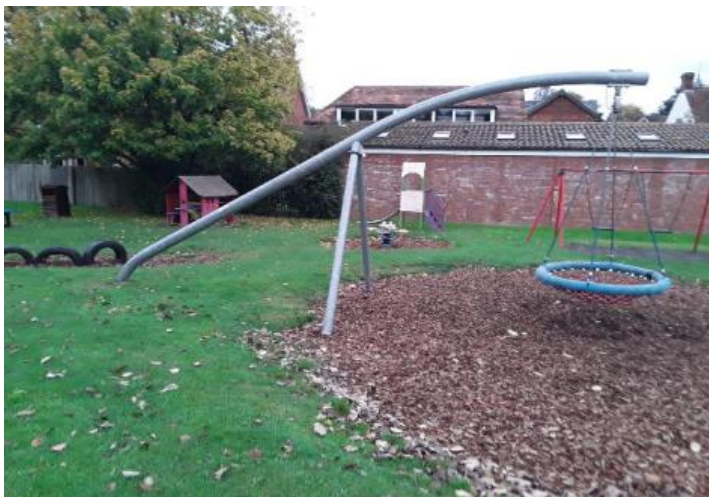
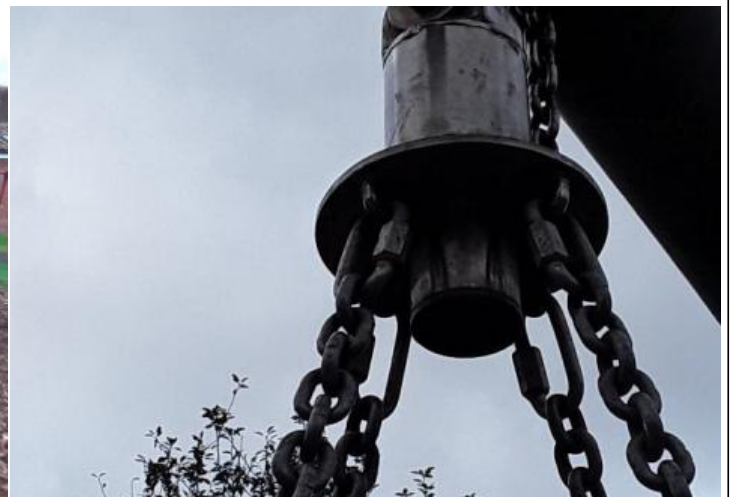
**Finding:** The connecting lugs are showing signs of wear

**Action:** Monitor for any further deterioration and repair as required

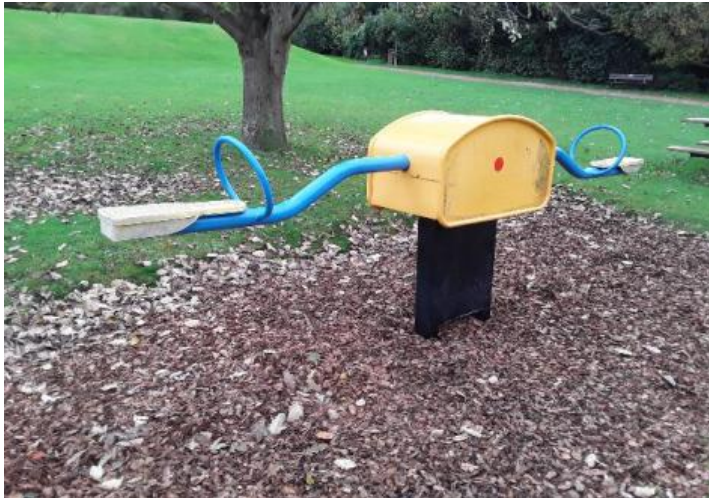
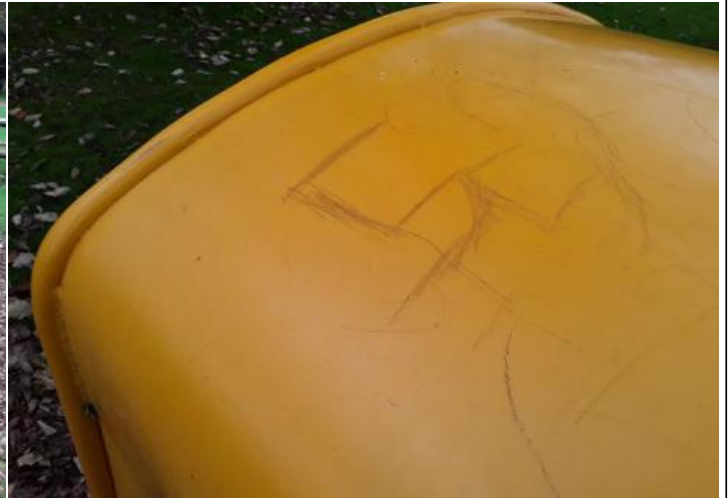
**Finding:** There is some graffiti present

**Action:** Remove the graffiti

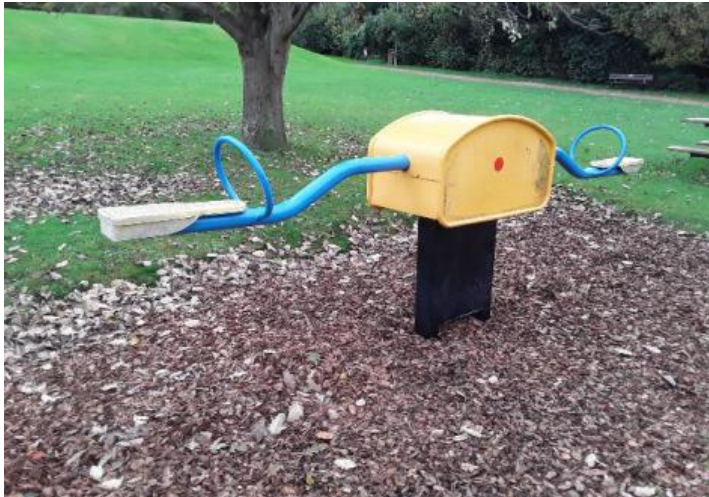
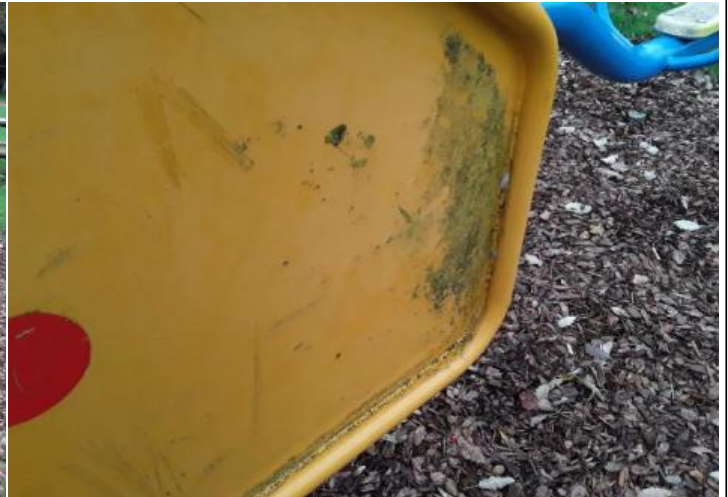
**Finding:** There is algae or moss on the surface of the equipment

**Action:** Clean and treat appropriately
