Annual Inspection

Kimpton Parish Council - Wren Close

Inspection Ref: 1497112

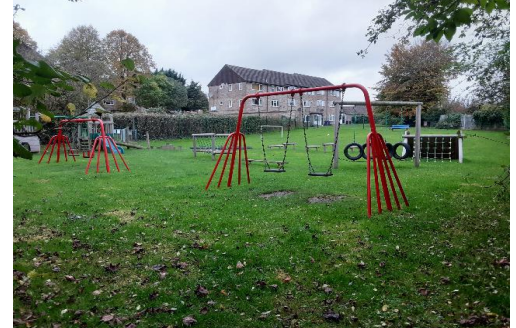
The grass mats are silted up and the soil is compacted; this may have an effect on the impact absorbing properties of the surface - Consider HIC testing impact absorbing properties to ensure the correct surface qualities are maintained for the equipment and replace as required

There is some strimmer / machinery damage apparent on the posts, this can penetrate the preservative applied to the timber and accelerate the rotting process - Monitor for any deterioration (rot) and replace as required

The timber has a number of splits/shakes or air cracks and this may affect the stability or allow water ingress which will accelerate the rotting process - Monitor to ensure the splits do not cross through fixing points of the structure and/or cause any instability

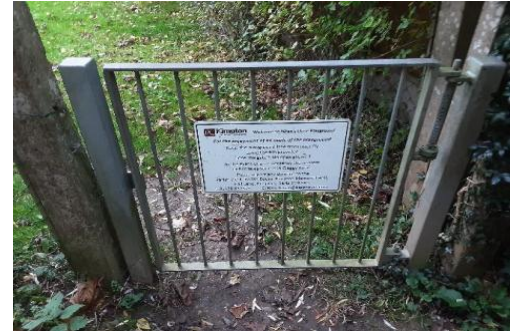
The area around the item has eroded and may become slippery - Reinstate eroded area

The gate is not operating correctly - Take effective action to ensure the gate closes between 4 and 8 seconds

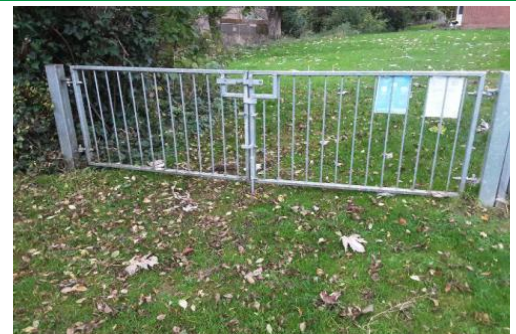
The gate has no drop bolt sleeves and/or drop bolts fitted - Provide drop bolt sleeves and/or drop bolts

There is no padlock on the maintenance gate - Provide a padlock to secure the gate

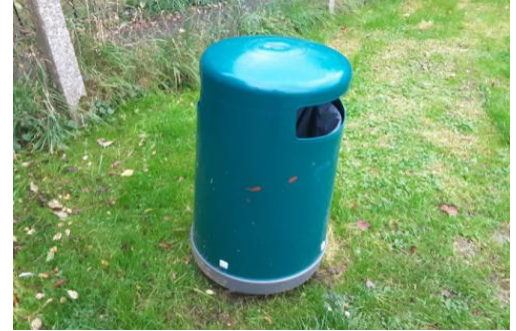
There is fire damage to the item - Monitor for any further deterioration and repair as required

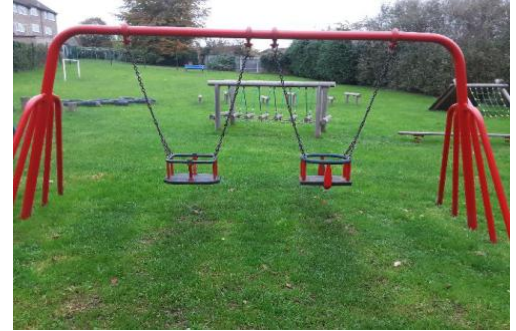
The chain openings are in excess of the 8.6mm as recommended by BS EN 1176 - Monitor - No remedial work recommended

There is some notable evidence of chain wear - Monitor for any further deterioration and replace when 40% worn

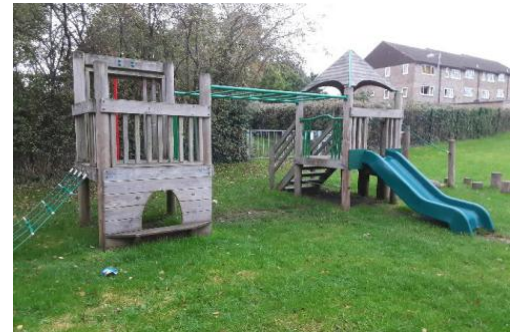
The plywood has delaminated in some places - Remove all rough or splintered edges.

There is/are finger entrapment/s in the structure and the item fails to meet the requirements of BS EN 1176 Part 1 4.2.7.6 Entrapment of fingers - Monitor - No remedial work recommended

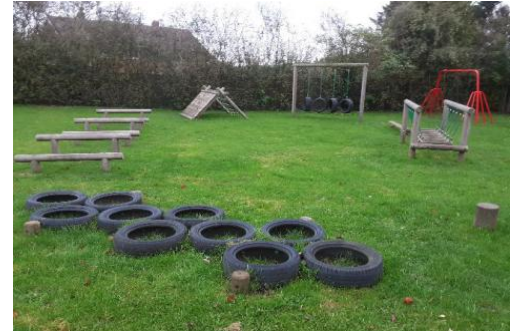
The connecting links are in excess of 8.6mm and less than 12mm and fail the requirements of BS EN 1176 Part 1; clause 4.2.13, Chains - Monitor use and replace with compliant links at the next maintenance cycle

The inspector has some concerns about the internal condition of the timber cross beam (discolouration of the timber may indicate internal rot) and was unable to verify the structural integrity without further testing. We recommend a Resi-PD survey to establish the condition of the timber at its core. - Contact the Play Inspection Company office for further information

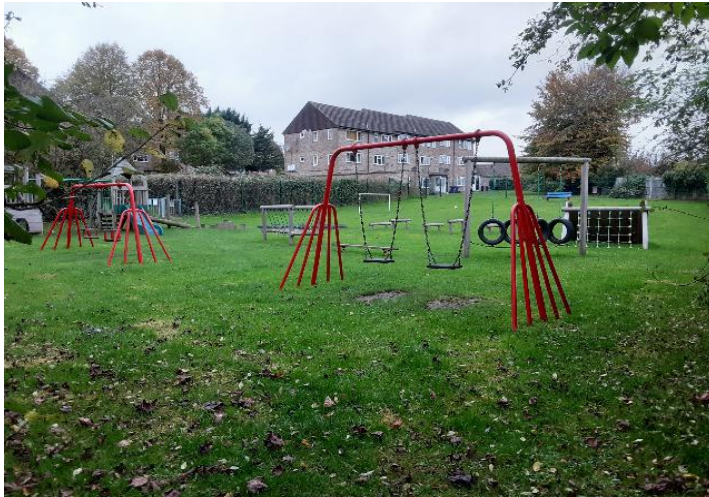
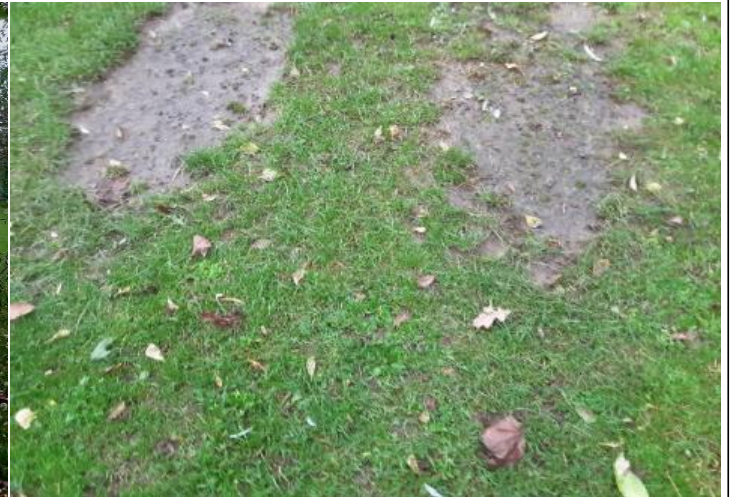
i 8 - Low Risk (Finding 1)

Finding: The grass mats are silted up and the soil is compacted; this may have an effect on the impact absorbing properties of the surface

Action: Consider HIC testing impact absorbing properties to ensure the correct surface qualities are maintained for the equipment and replace as required

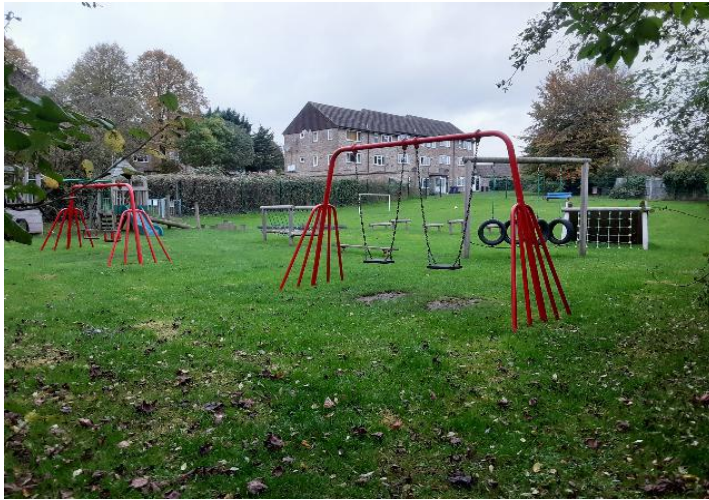
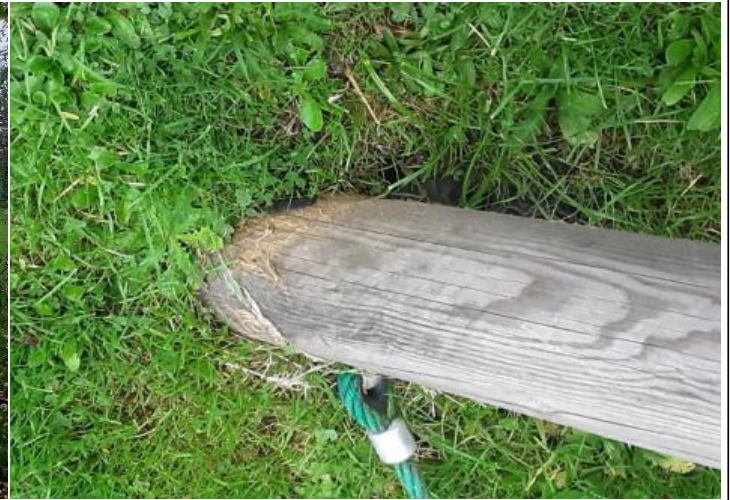
i 6 - Low Risk (Finding 2)

Finding: There is some strimmer / machinery damage apparent on the posts, this can penetrate the preservative applied to the timber and accelerate the rotting process

Action: Monitor for any deterioration (rot) and replace as required

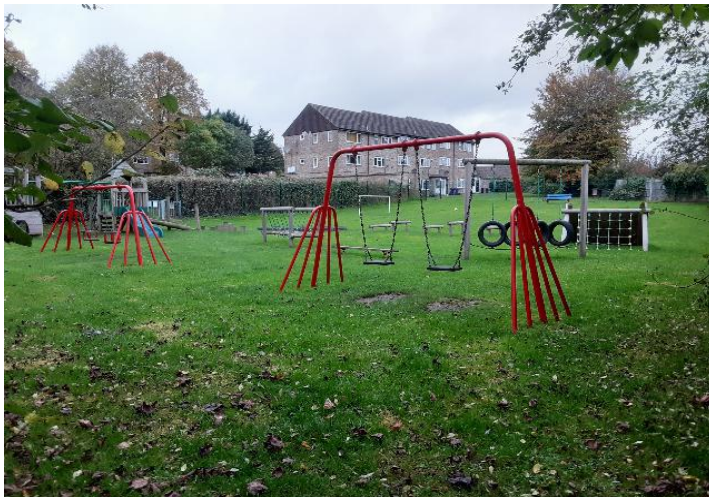
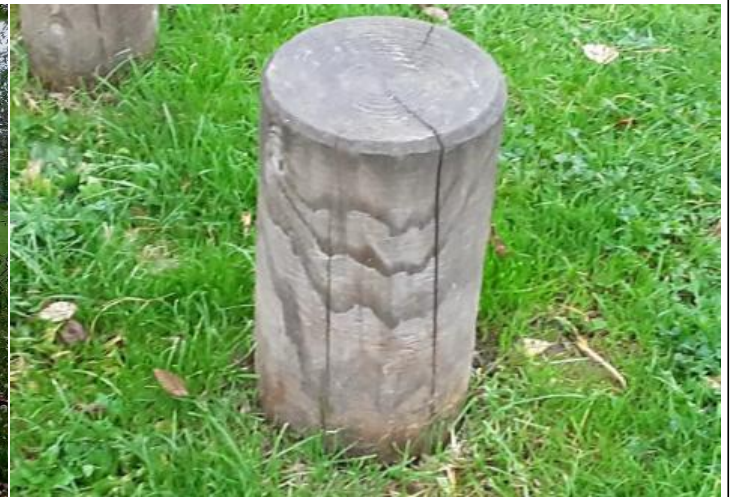
i 6 - Low Risk (Finding 3)

Finding: The timber has a number of splits/shakes or air cracks and this may affect the stability or allow water ingress which will accelerate the rotting process

Action: Monitor to ensure the splits do not cross through fixing points of the structure and/or cause any instability

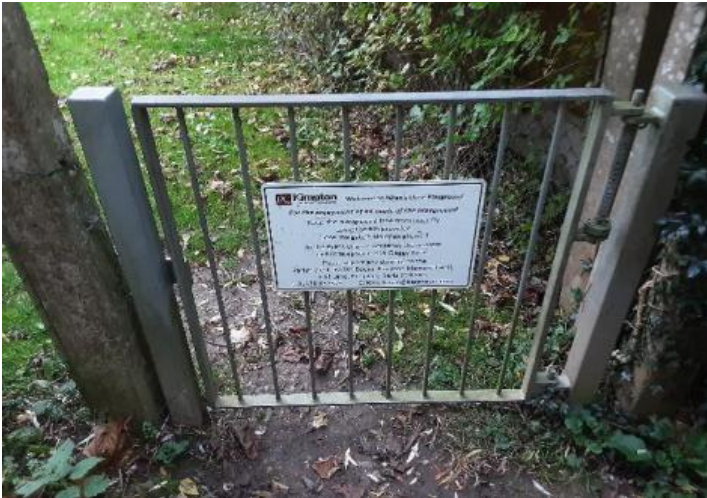
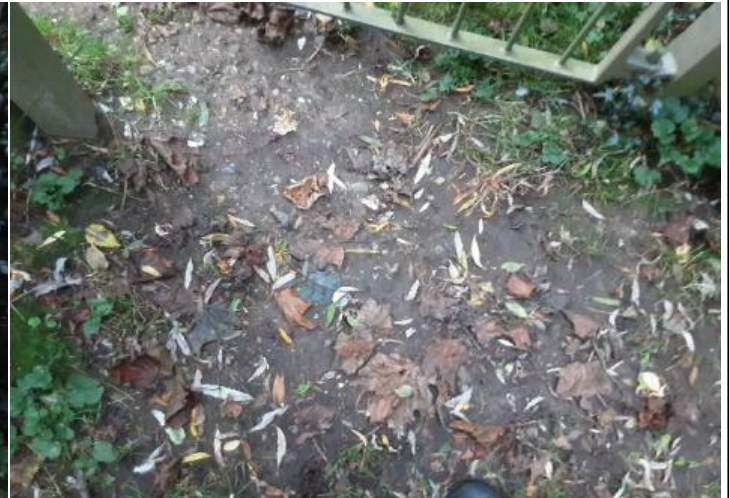
i 8 - Low Risk (Finding 1)

Finding: The area around the item has eroded and may become slippery

Action: Reinststate eroded area

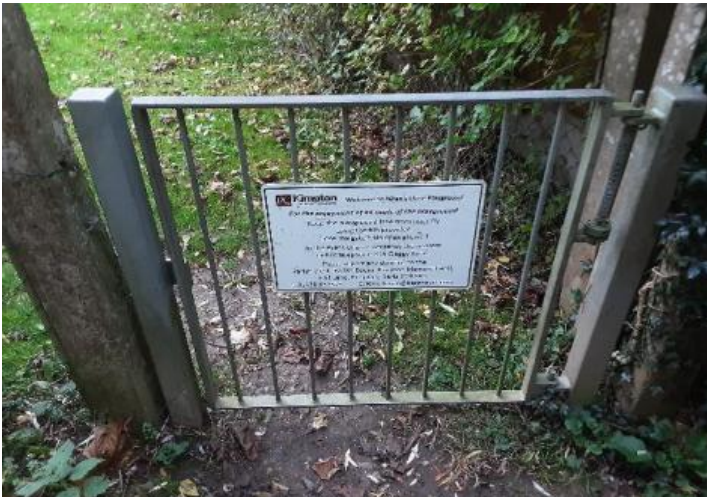
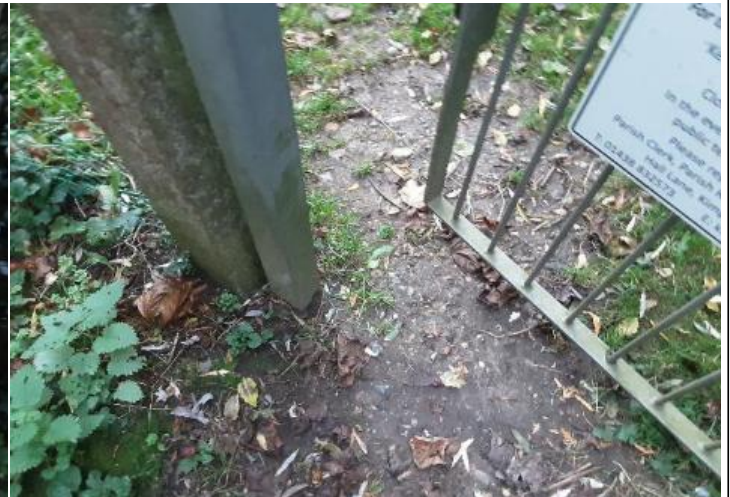
i 5 - Very Low Risk (Finding 2)

Finding: The gate is not operating correctly

Action: Take effective action to ensure the gate closes between 4 and 8 seconds

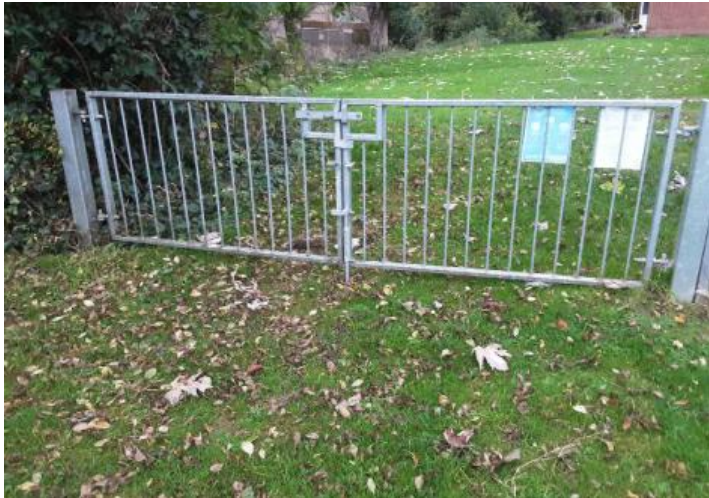
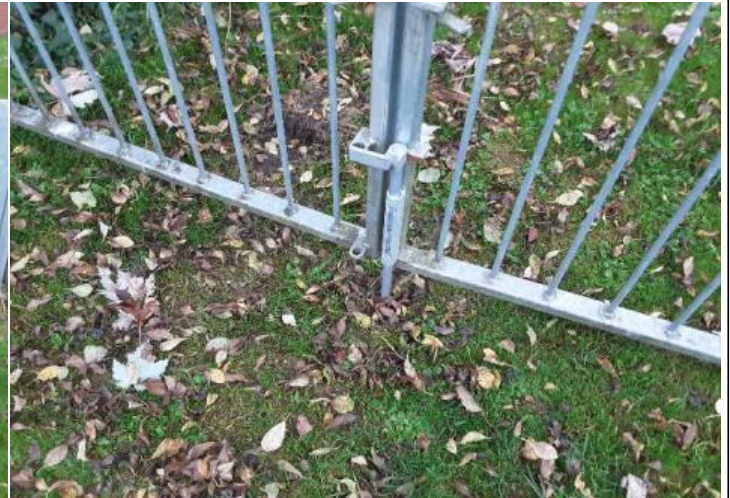
i 6 - Low Risk (Finding 1)

Finding: The gate has no drop bolt sleeves and/or drop bolts fitted

Action: Provide drop bolt sleeves and/or drop bolts

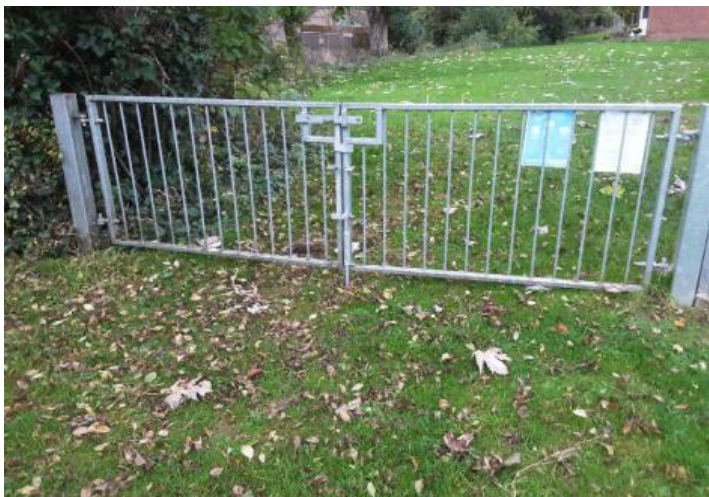
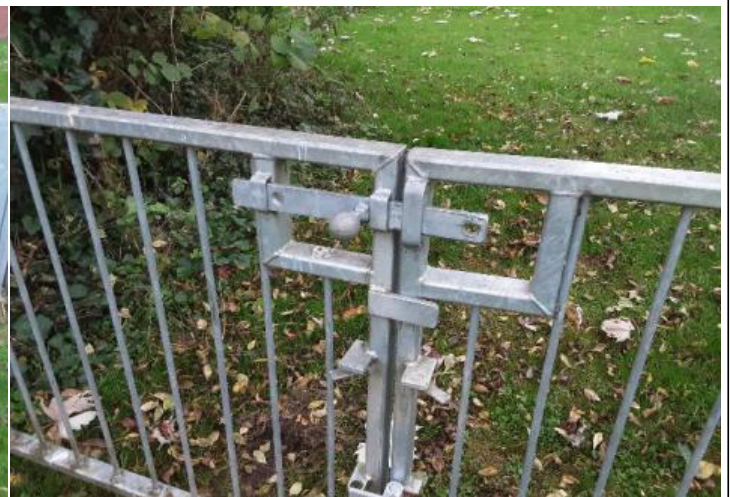
i 6 - Low Risk (Finding 2)

Finding: There is no padlock on the maintenance gate

Action: Provide a padlock to secure the gate

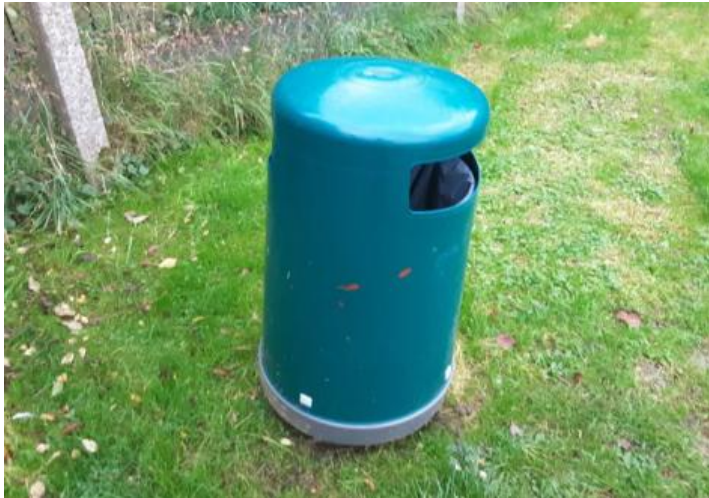
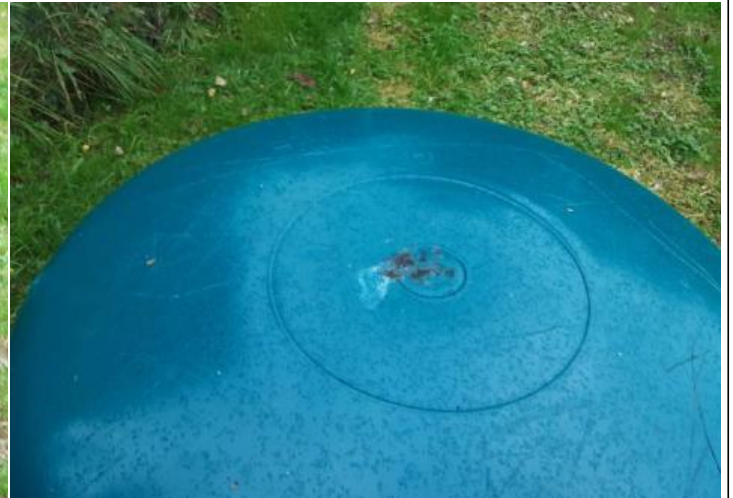
i 6 - Low Risk (Finding 1)

Finding: There is fire damage to the item **Action:** Monitor for any further deterioration and repair as required

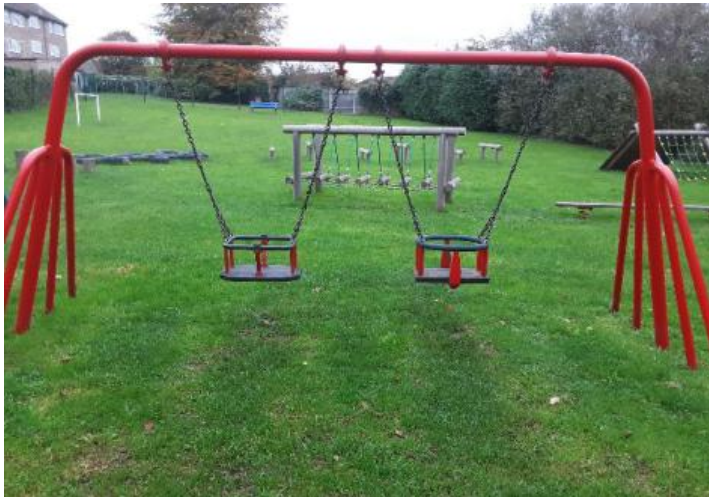
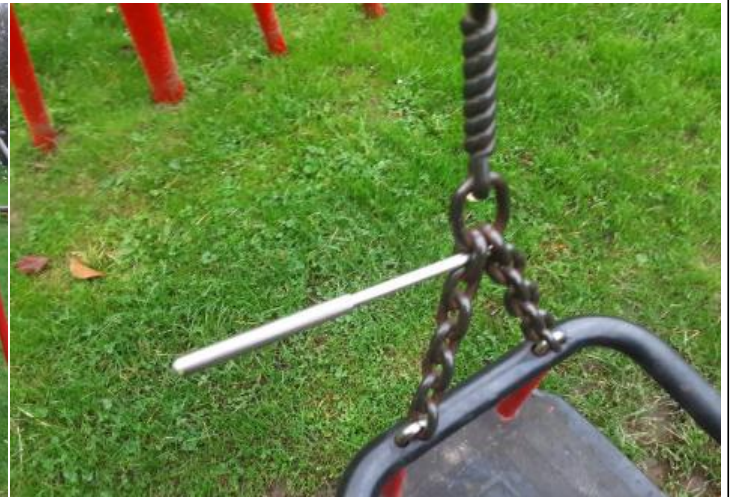
i 5 - Very Low Risk (Finding 1)

Finding: The chain openings are in excess of the 8.6mm as recommended by BS EN 1176 **Action:** Monitor - No remedial work recommended

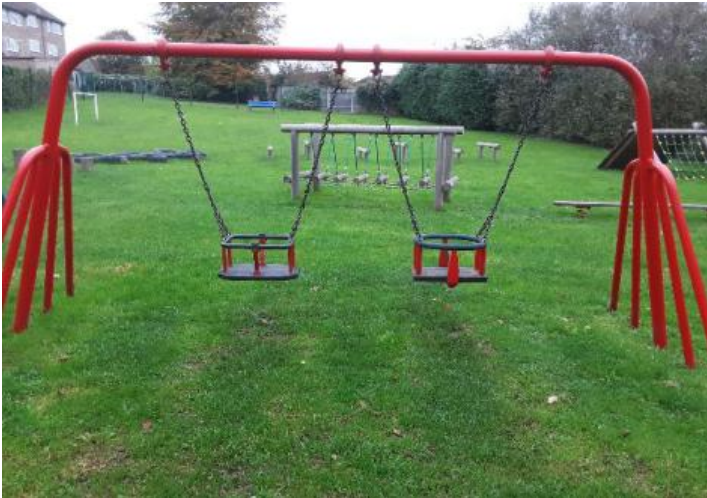
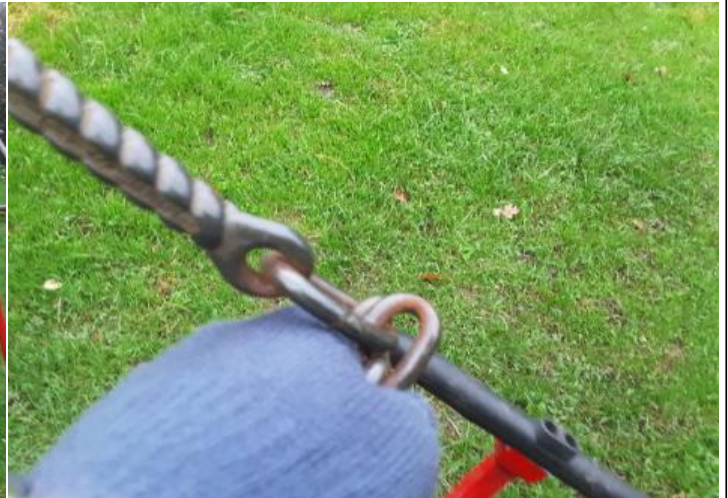
i 6 - Low Risk (Finding 2)

Finding: There is some notable evidence of chain wear

Action: Monitor for any further deterioration and replace when 40% worn

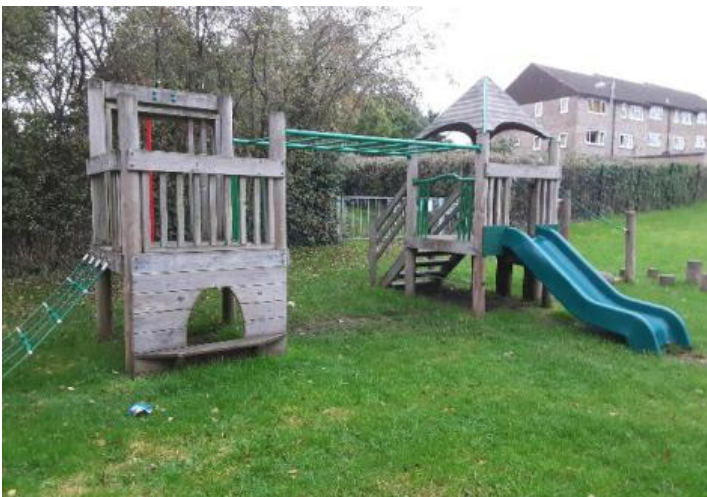
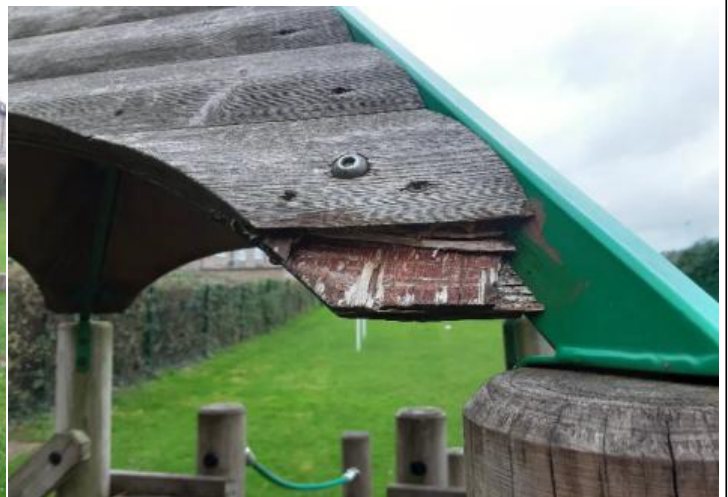
i 6 - Low Risk (Finding 1)

Finding: The plywood has delaminated in some places

Action: Remove all rough or splintered edges.

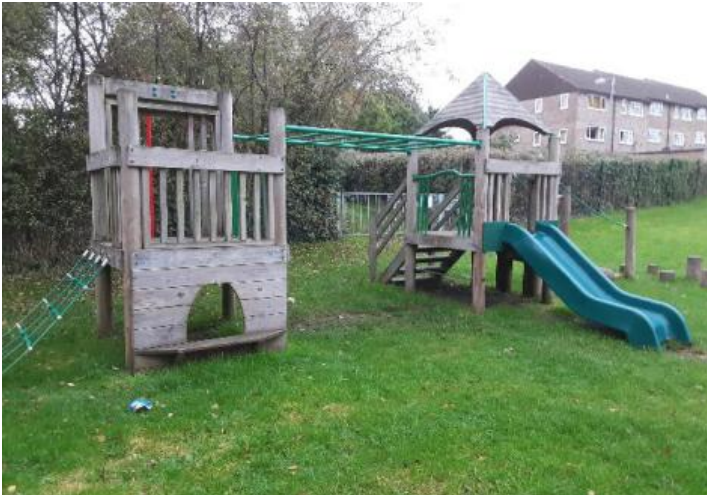
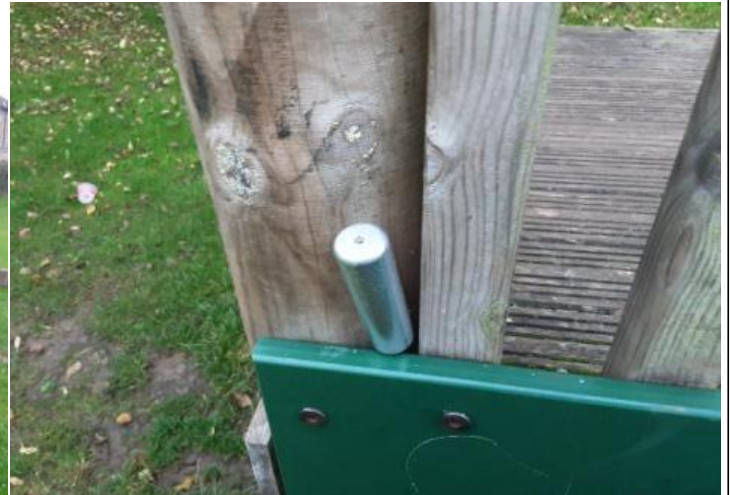
i 5 - Very Low Risk (Finding 2)

Finding: There is/are finger entrapment/s in the structure and the item fails to meet the requirements of BS EN 1176 Part 1 4.2.7.6 Entrapment of fingers

Action: Monitor - No remedial work recommended

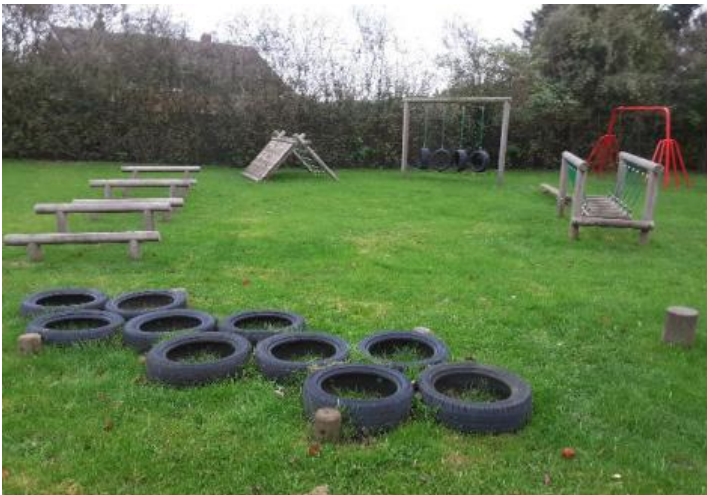
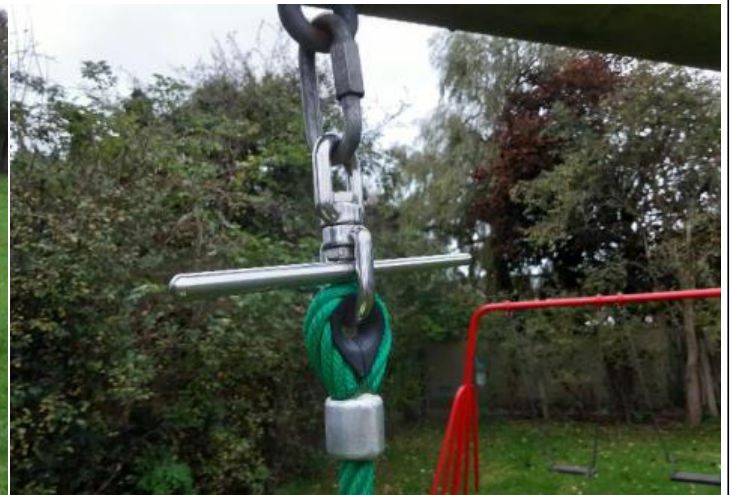
i 5 - Very Low Risk (Finding 1)

Finding: The connecting links are in excess of 8.6mm and less than 12mm and fail the requirements of BS EN 1176 Part 1; clause 4.2.13, Chains

Action: Monitor use and replace with compliant links at the next maintenance cycle

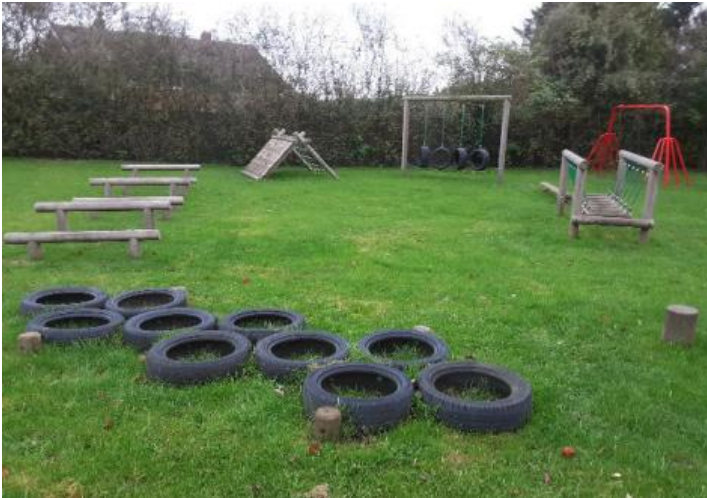
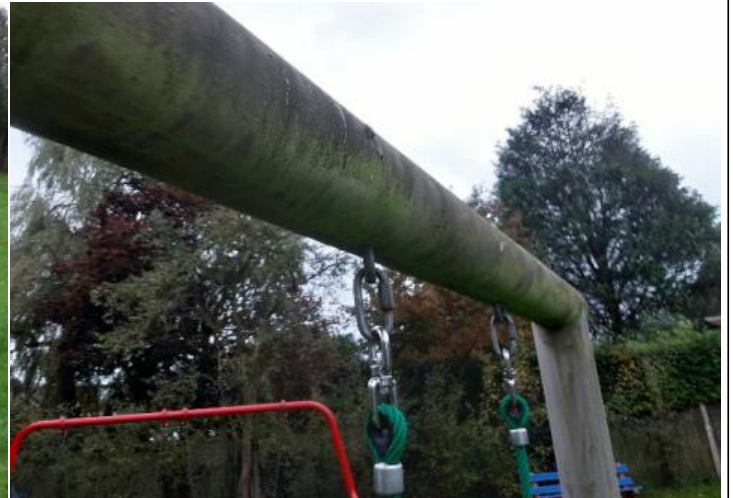
i 0 - Risk Assessment not Undertaken (Finding 2)

Finding: The inspector has some concerns about the internal condition of the timber cross beam (discolouration of the timber may indicate internal rot) and was unable to verify the structural integrity without further testing. We recommend a Resi-PD survey to establish the condition of the timber at it's core.

Action: Contact the Play Inspection Company office for further information
