# the **play inspection** company

## Annual Inspection

Kimpton Parish Council - Recreation Ground

Inspection Ref: 1498980

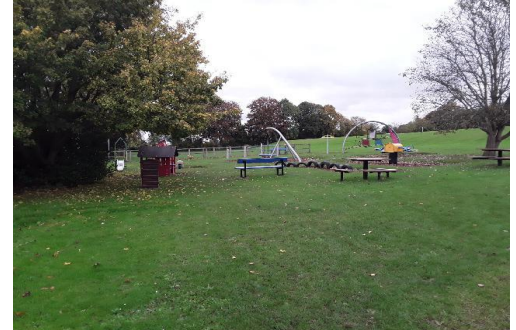
**Item:** Site General  
**Manufacturer:** Owner/Operator  
**Surface Type:** N/A  
**Item Quantity:** 1  
**Equipment Compliance:** N/A  
**Surface Area Compliance:** N/A

There is tree debris on the surfacing - Remove and maintain

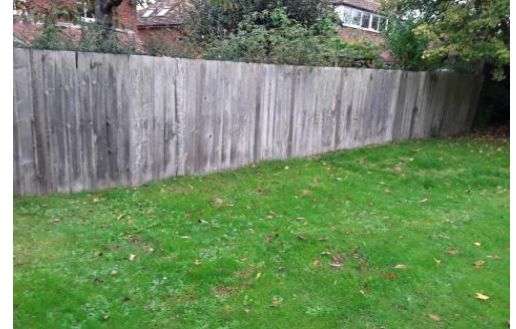
**Item:** Fencing - Timber  
**Manufacturer:** Not Identified  
**Surface Type:** N/A  
**Item Quantity:** 1  
**Equipment Compliance:** N/A  
**Surface Area Compliance:** N/A

There is some damage to the fence sections - Monitor for any further deterioration and repair as required

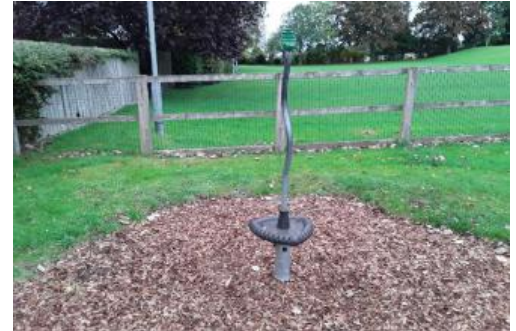
**Item:** Spinning Pole  
**Manufacturer:** Kompan Ltd  
**Surface Type:** Bark Mulch  
**Item Quantity:** 1  
**Equipment Compliance:** Yes  
**Surface Area Compliance:** Yes

**i** 4 - Very Low Risk

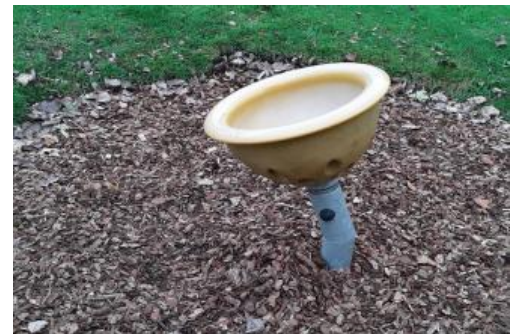
**Item:** Spinner Bowl  
**Manufacturer:** Kompan Ltd  
**Surface Type:** Bark Mulch  
**Item Quantity:** 1  
**Equipment Compliance:** Yes  
**Surface Area Compliance:** Yes

**i** 4 - Very Low Risk

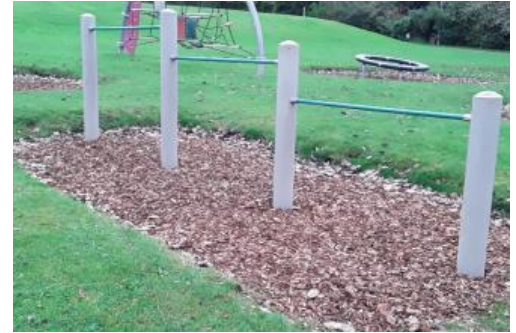
**Item:** Somersault Bars  
**Manufacturer:** Monster Play Systems  
**Surface Type:** Bark Mulch  
**Item Quantity:** 1  
**Equipment Compliance:** Yes  
**Surface Area Compliance:** Yes

**i** 4 - Very Low Risk

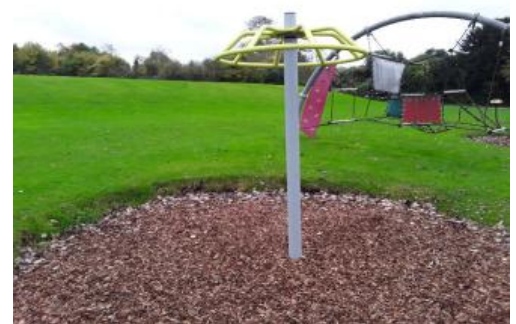
**Item:** Overhead Rotator  
**Manufacturer:** S M P (Playgrounds Ltd)  
**Surface Type:** Bark Mulch  
**Item Quantity:** 1  
**Equipment Compliance:** Yes  
**Surface Area Compliance:** Yes

**i** 4 - Very Low Risk

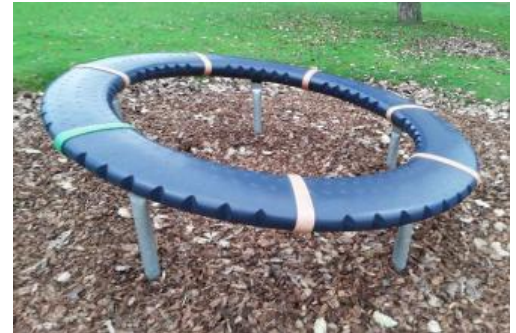
**Item:** Supernova  
**Manufacturer:** Kompan Ltd  
**Surface Type:** Bark Mulch  
**Item Quantity:** 1  
**Equipment Compliance:** Yes  
**Surface Area Compliance:** Yes

**i 4 - Very Low Risk**

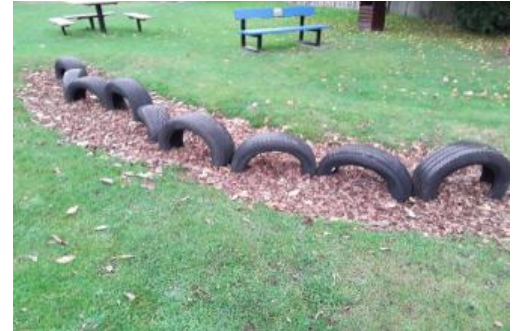
**Item:** Tyre Trail  
**Manufacturer:** Not Identified  
**Surface Type:** Bark Mulch  
**Item Quantity:** 1  
**Equipment Compliance:** Yes  
**Surface Area Compliance:** Yes

This item is satisfactory - no work required -
