Annual Inspection

Kimpton Parish Council - Wren Close

Inspection Ref: 1497112

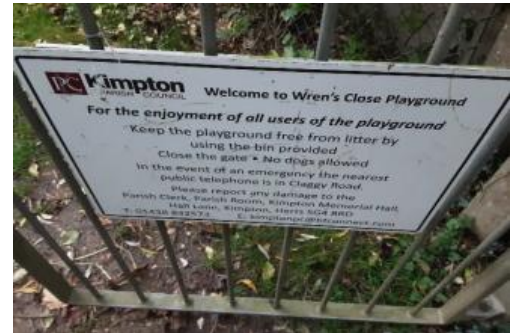
i 4 - Very Low Risk

Item: Sign
Manufacturer: Unknown
Surface Type: All Weather Surface
Item Quantity: 1
Equipment Compliance: N/A
Surface Area Compliance: N/A

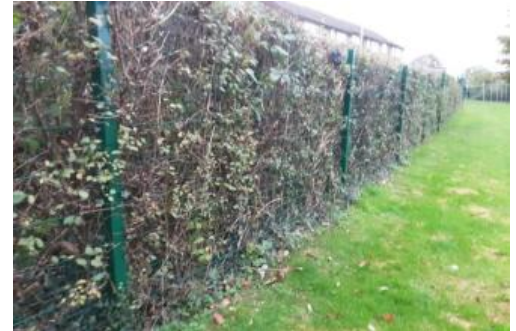
i 4 - Very Low Risk

Item: Fence - Steel Mesh
Manufacturer: Owner/Operator
Surface Type: N/A
Item Quantity: 1
Equipment Compliance: N/A
Surface Area Compliance: N/A

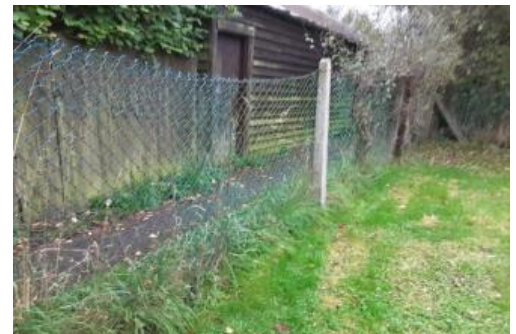
i 4 - Very Low Risk

Item: Fence - Chainlink
Manufacturer: Not Identified
Surface Type: Grass
Item Quantity: 1
Equipment Compliance: N/A
Surface Area Compliance: N/A

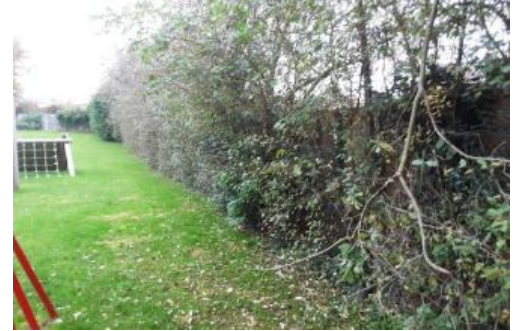
i 4 - Very Low Risk

Item: Hedge
Manufacturer: Owner/Operator
Surface Type: N/A
Item Quantity: 1
Equipment Compliance: N/A
Surface Area Compliance: N/A

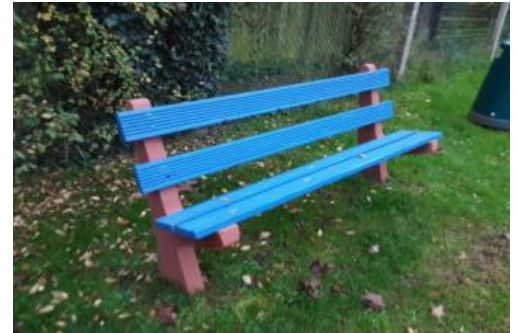
i 4 - Very Low Risk

Item: Bench
Manufacturer: Owner/Operator
Surface Type: N/A
Item Quantity: 2
Equipment Compliance: N/A
Surface Area Compliance: N/A

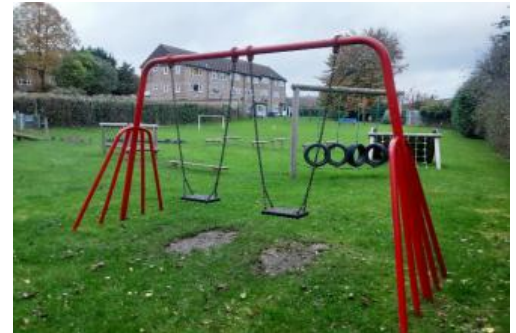
i 4 - Very Low Risk

Item: 1 Bay 2 Seat (Flat)
Manufacturer: Wicksteed Playgrounds
Surface Type: Grass Matrix Tiles
Item Quantity: 1
Equipment Compliance: Yes
Surface Area Compliance: Yes
